Residential property inspection report.

Inspector/s: Keith and Bronwyn Langham, ASAP Building Inspections Ltd.

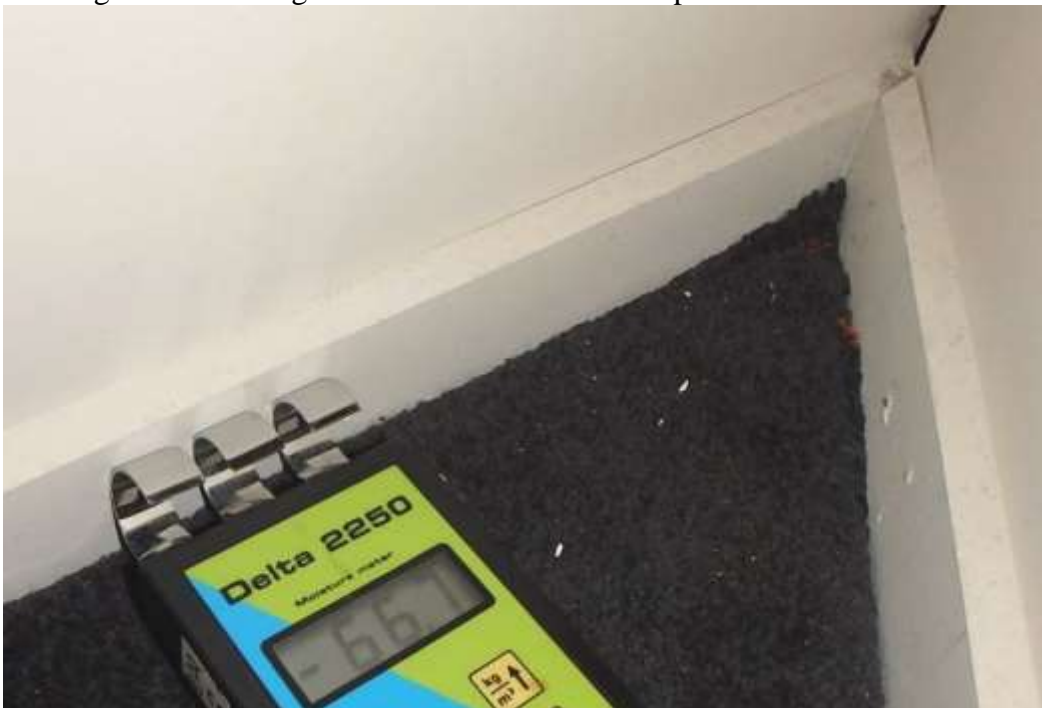
However, there were some very elevated moisture readings up to 67.5 found in the skirting inside the storage cupboard in the area adjacent to the front corner of the shower. The bottom of the skirting was swollen, a sign that MDF has been or is wet. Readings in the plaster board just above the skirting were only slightly elevated at up to 10.9. We suggest the bottom of the framing in this area of wall should be investigated further for deterioration. This may also be a good area to try to ascertain where the moisture is coming from.

Very high moisture readings behind the shower suggest a leak or failure.

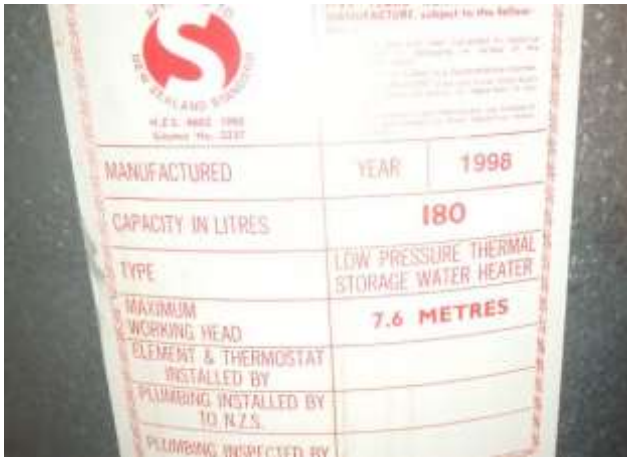
The hot water cylinder is the left end of the linen cupboard. It is dated as manufactured in 1998 and is a 180 litre low pressure storage tank. It sits on a framed timber shelf and only has one seismic restraining strap that is secured by standard Gib screws.

1998 low pressure HWC

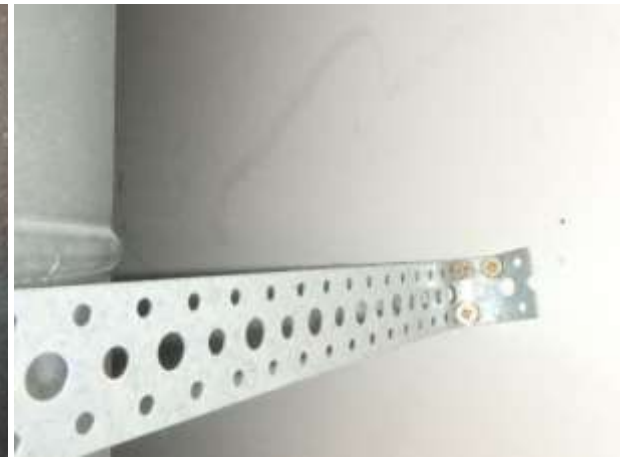
screws should be a bit more substantial

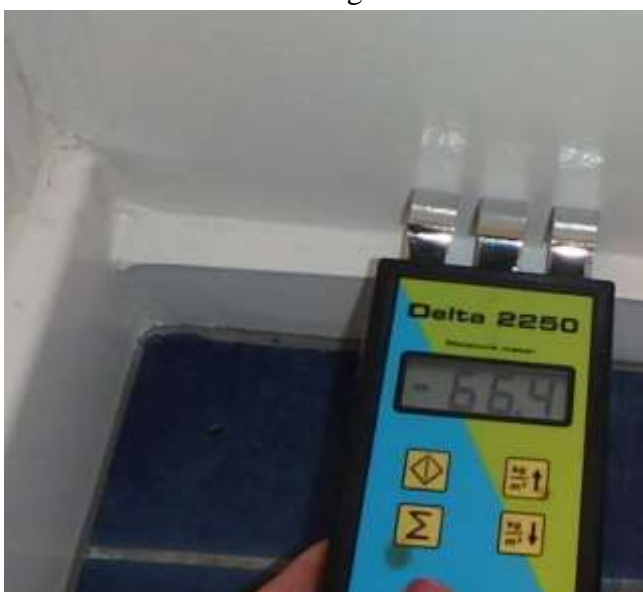
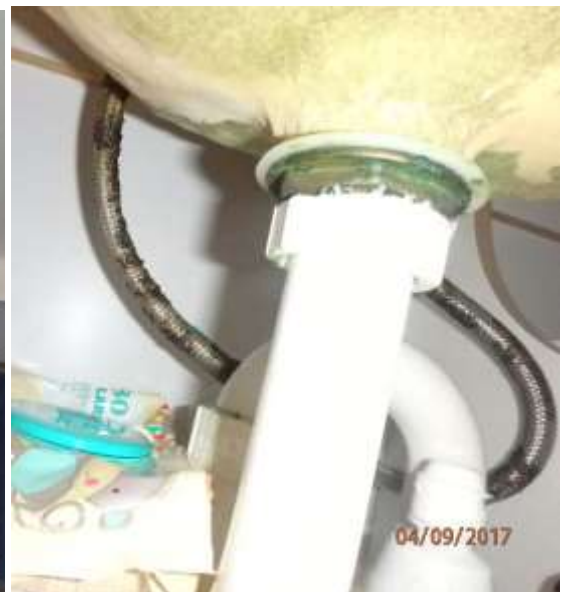
The vanity unit has taps with flexible hose pipes and uPVC. The hoses are in poor condition and appear to have corrosion on their surface. Water pressure at the cold tap was very good but pressure from the hot tap was quite a bit lower.

Moisture readings were very elevated readings of up to 66 just above the skirting on the wall adjacent to bedroom 2 between the shower and the toilet. Readings in the skirting were also higher here at up to 21.8 along this piece of wall and the skirting looked swollen, thicker at the end closer to the shower.

Very high readings suggesting a leak around the shower. Something on the pipes.

This area should be investigated further.

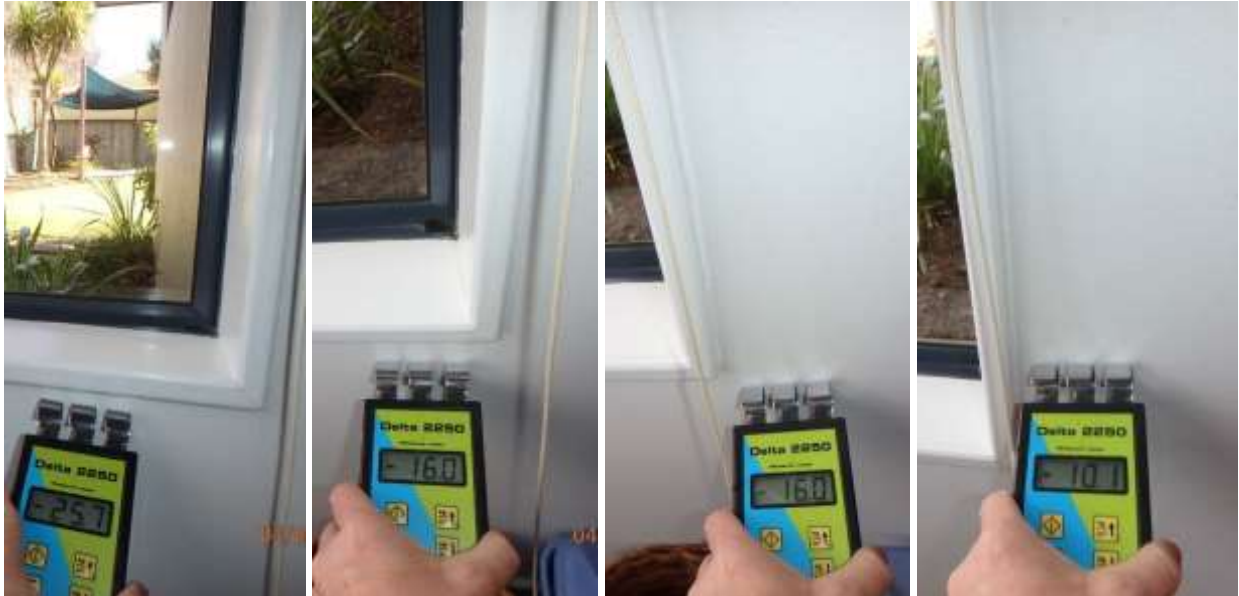
This room has a corner window in western corner where there is a step in the southwest wall. There were elevated moisture readings of 26 found directly under the right end of the sill on the northwest wall but readings in the skirting and the lower area of wall here did not appear elevated. Readings under the remainder of this window were below 9.8. There is a repaired sheet joint crack under this end of the window. The sills are not sitting flush where they meet at the mitre join in the corner of the window.

Moisture readings were slightly elevated at up to 16.7 in the skirting along the southeast wall and readings in the bottom of the plaster board along this wall were also up a little compared to further up the wall. These readings are not considered high but just noted as being higher than those around the remainder of the house and may be due to the aspect of this wall. Lowering the gardens outside may be all that is required.

Moisture readings are not high but should be monitored for mould or mildew growth.

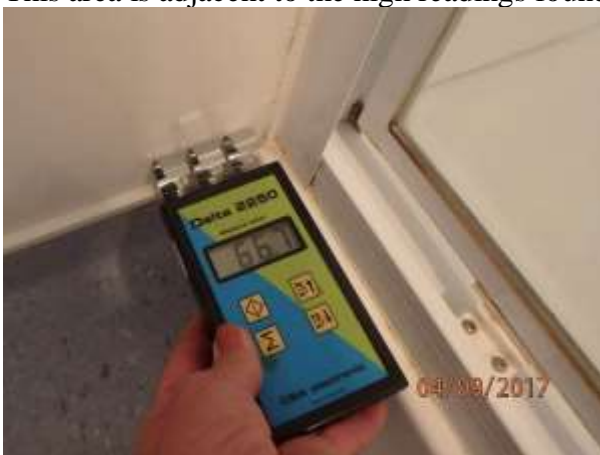
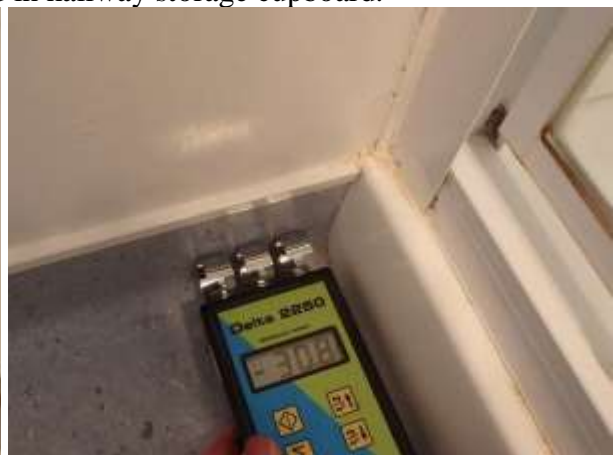
The bottom edge of the bathroom door binds on the jamb. This is likely to be due to swelling in the timbers between the door and the shower as elevated moisture readings were found near the shower with 30 in the coved area of the vinyl flooring and 66 in the bottom of the plaster board. The readings reduced moving toward the bathroom door.

This area is adjacent to the high readings found in hallway storage cupboard.

Very high readings to the left of the shower

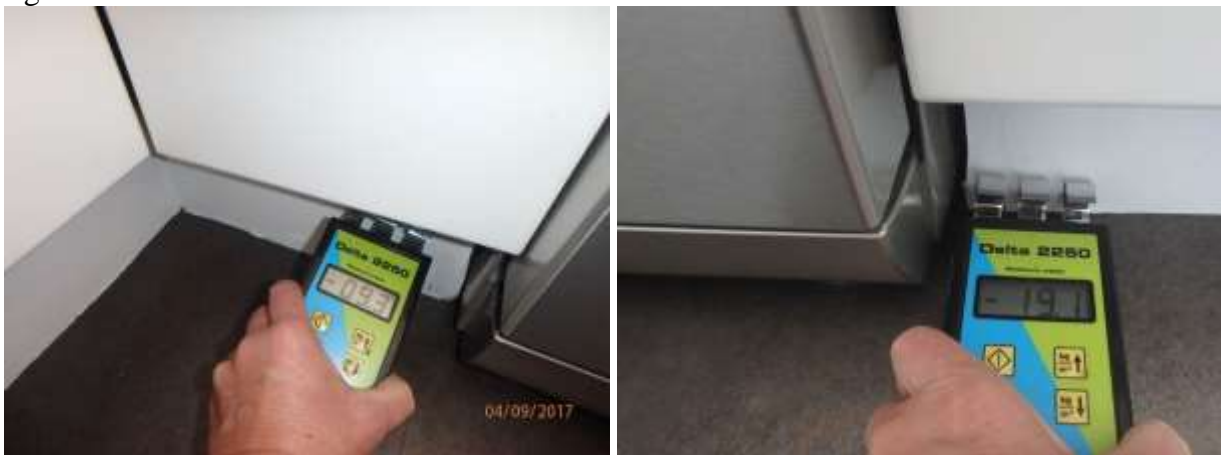
The toe space edge of the cupboard panels either side of the dishwasher are a bit swollen from water damage and there is also some swelling in the bottom of the toe space under the sink. Moisture readings along the toe spaces ranged between 11 and 19, the higher readings to the right of the dishwasher.

Each side of the dishwasher with a raised reading on the right

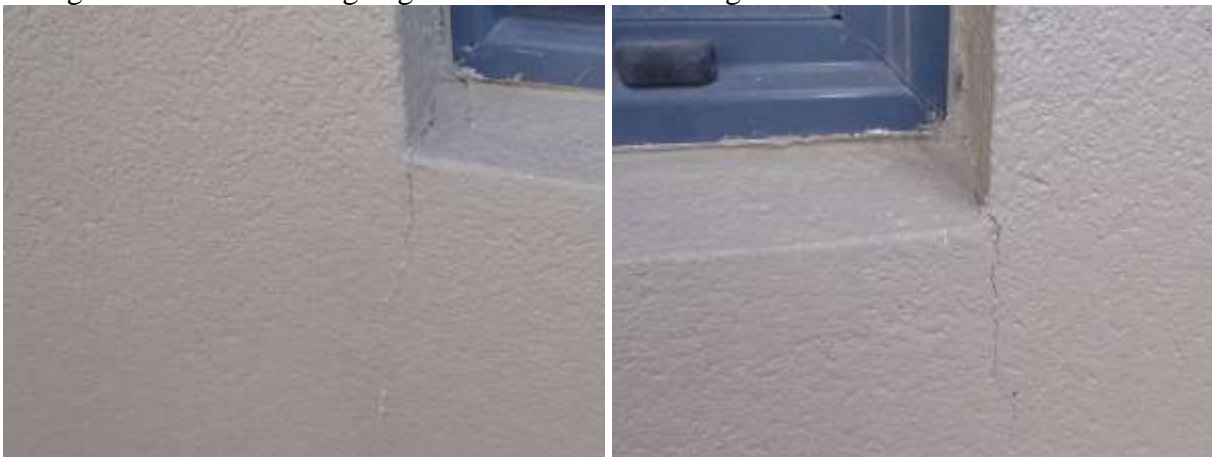
The plaster on this side is just dirty with a few fine cracks from the corners of the windows just time for a wash and fresh paint.

Cracks like this just need to be coated with a special sealer and the wall repainted.

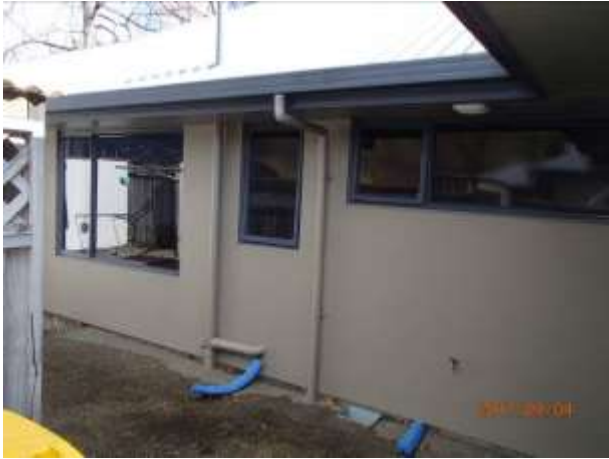
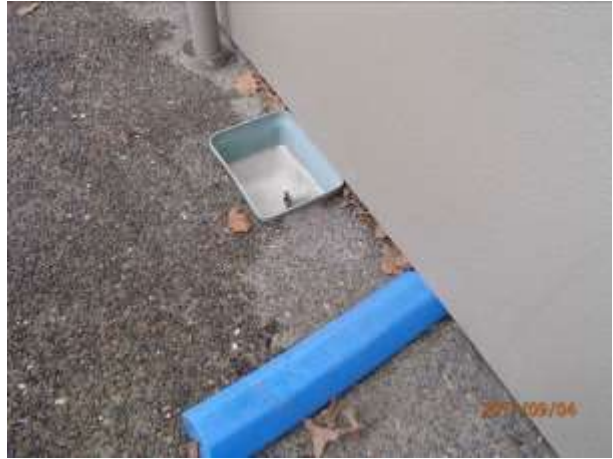
The wall is generally tidy but the gully trap needs a grill installed. Balls, hedgehogs and even cats can get in here and block the sewer.

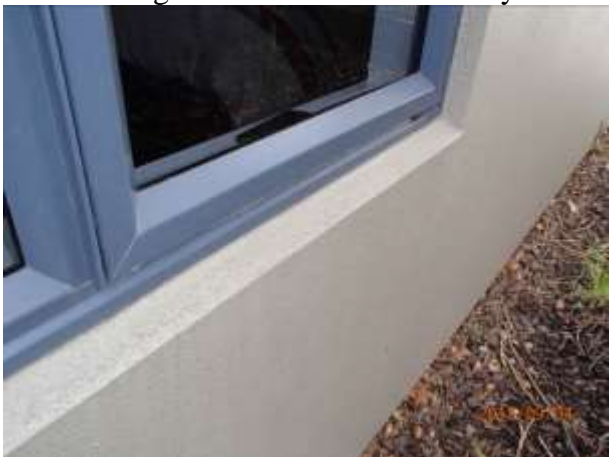
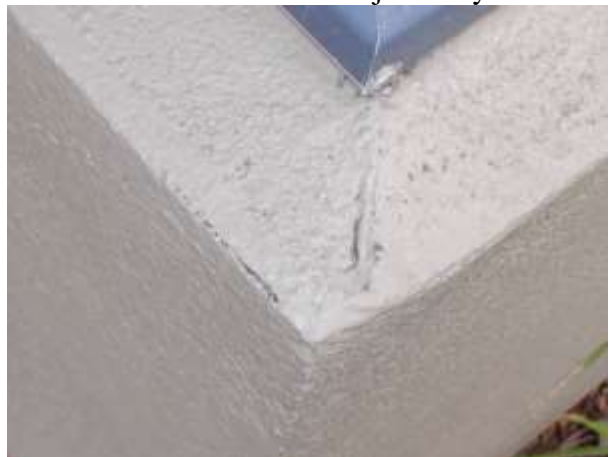
The plaster has a lot of grit and grime in the surface and some separation.

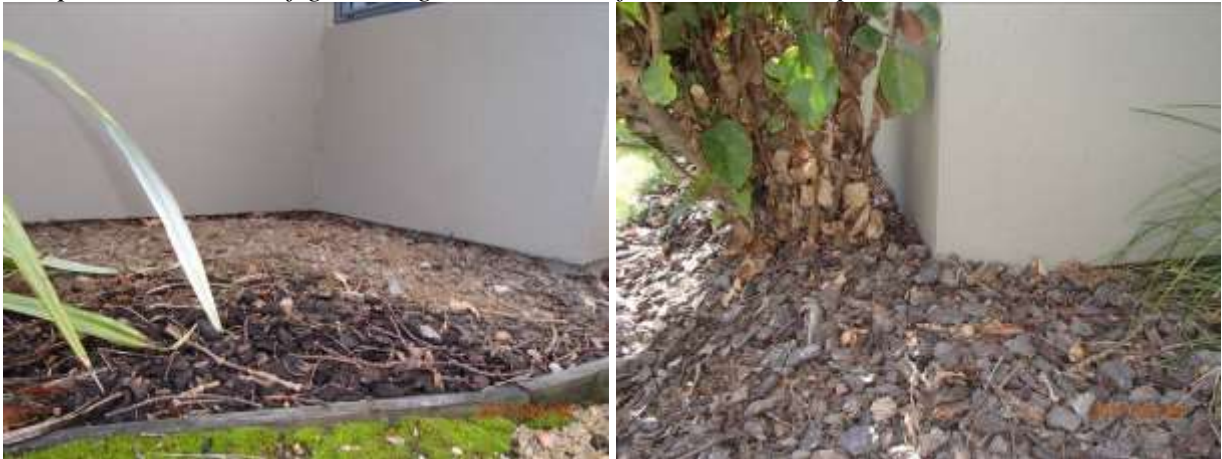
This area backs onto the school grounds. Bark gardens here are too high and need to be lowered, especially around the western corner where it is above the bottom of the cladding. Plaster along this wall is not affected by UV or heat so is in better condition just dirty.

These gardens are just too high and must be lowered.

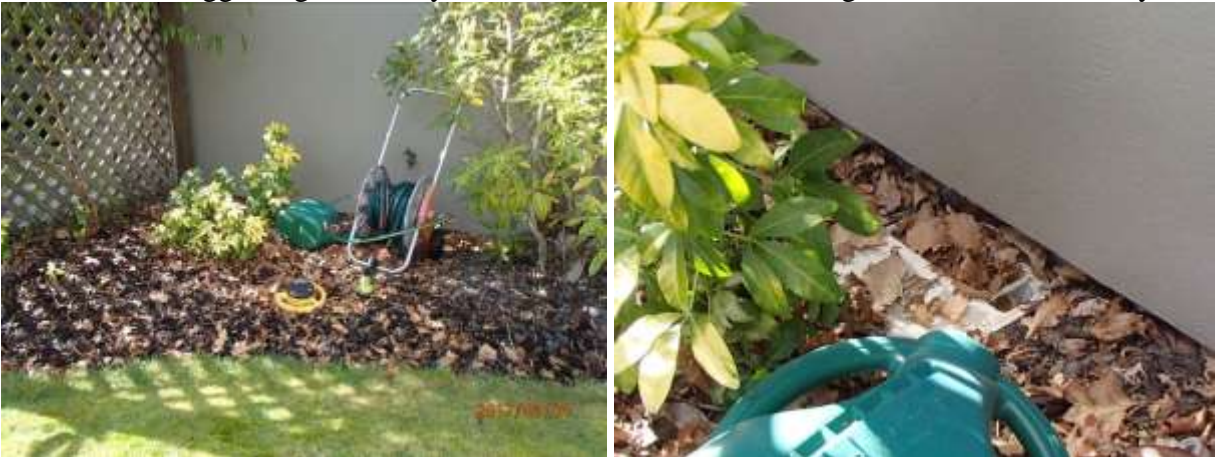
Gardens along the bedroom wall are way too high and a gully trap is buried. This should be 100 mm above ground level so the garden has been built up quite a bit.

Garden levels are too high and this hidden gully is filling with leaves.

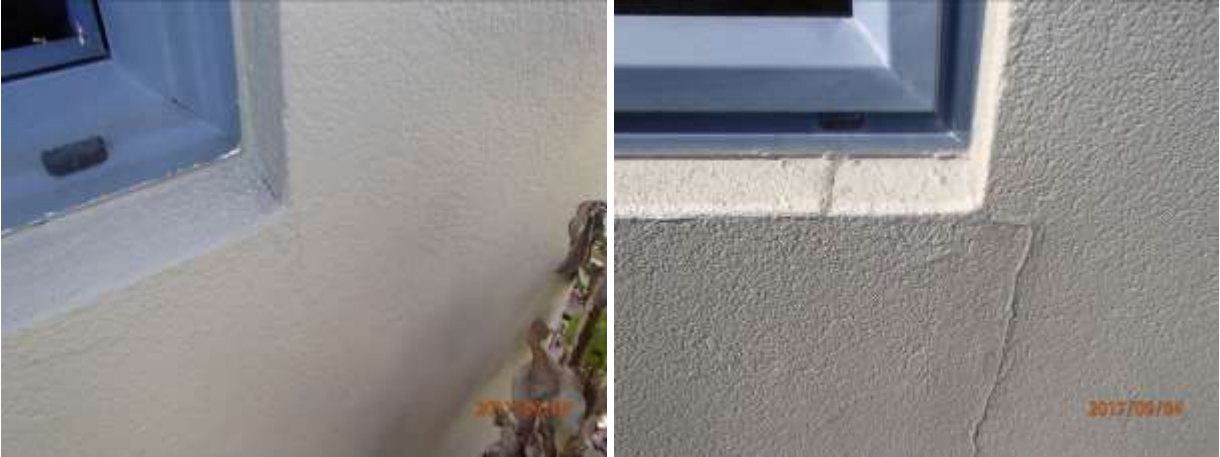
Some cracks have not been touched and some are very untidily patched

Cracking in the plaster to the corners of windows and the lifting of the plastic sill flashing under the plaster as well as the cracks in the face of the plaster all need to be fixed. The sills should be replaced, all cracks repaired and the wall repainted. Clear sealant is not a suitable repair.

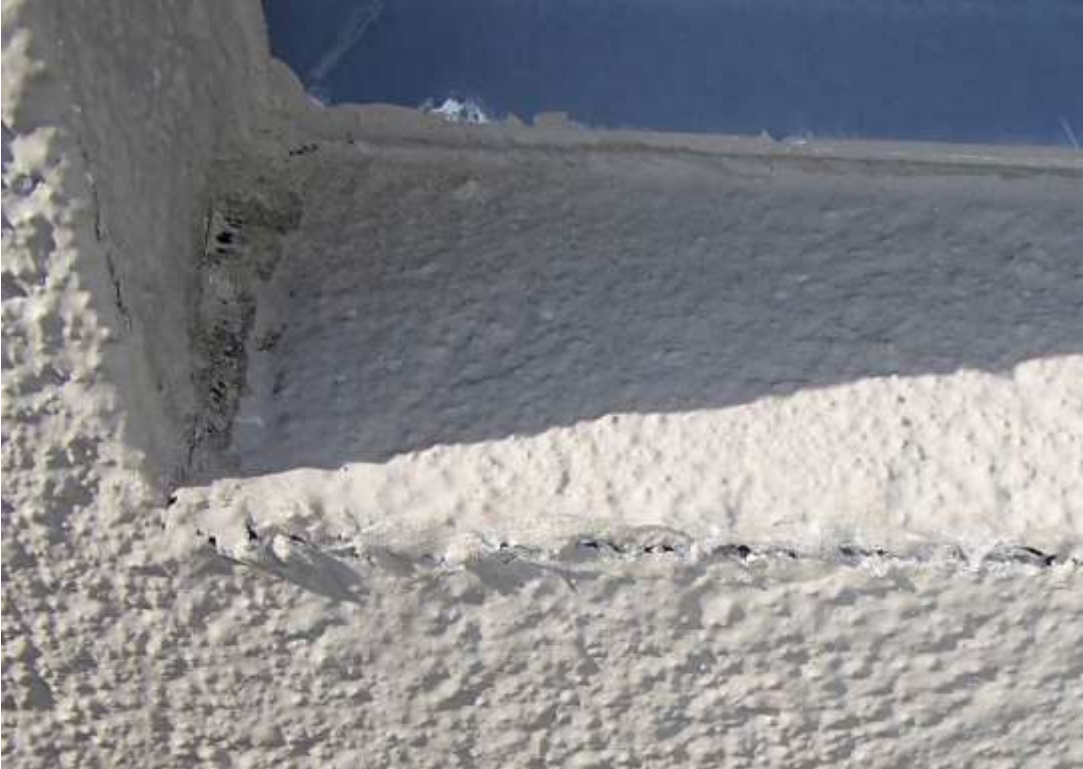
A lot of the sill flashings along this side and NE are lifting and need to be replaced.

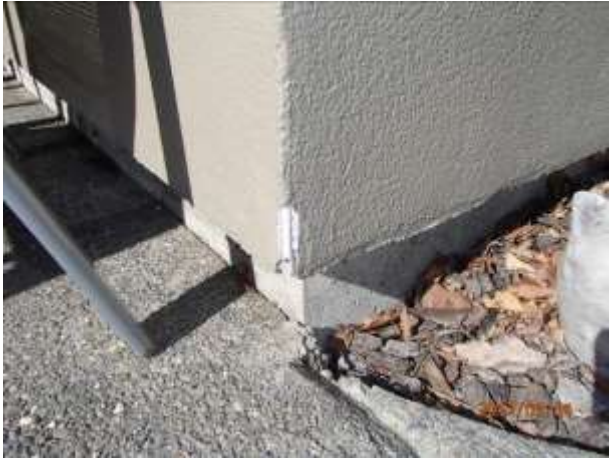
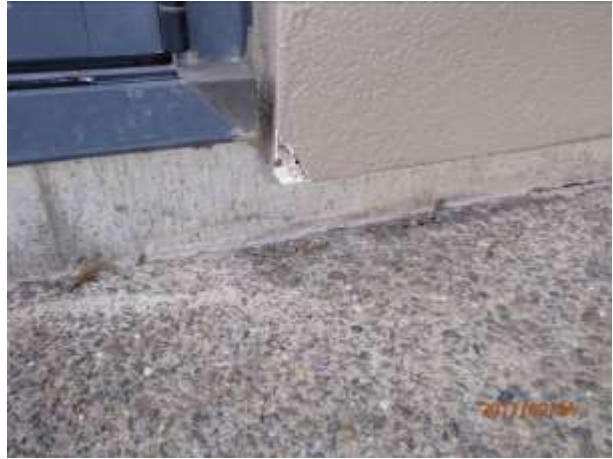
There are bruised corners to the plaster which expose the plastic corner flashings. This damage needs to be repaired.

Minor damage to some corners just needs to be repaired before repainting.

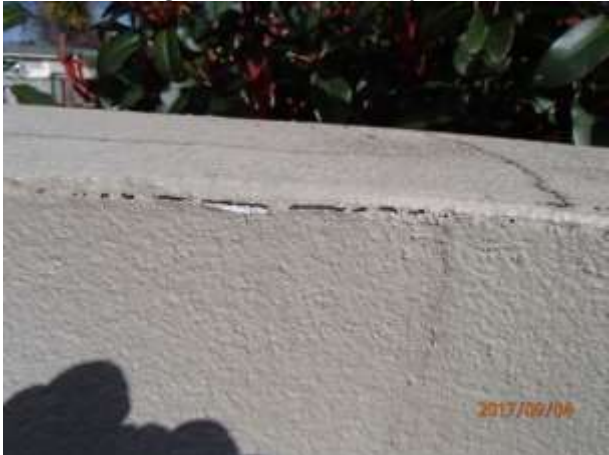
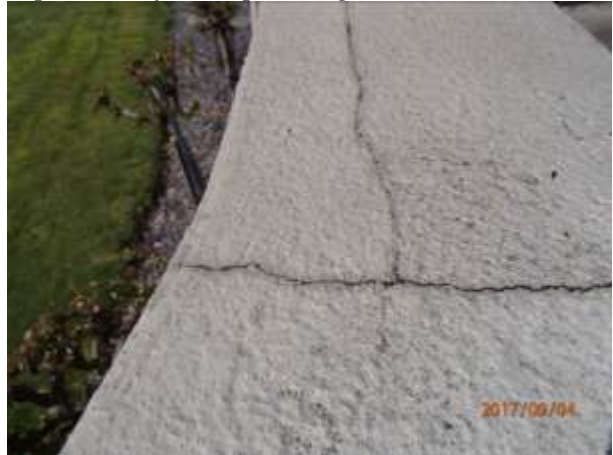
The curved wall is polystyrene over a timber frame and posts. It's a bit wobbly and I believe its life is limited as water is getting in at the top. Even where the gate hinges go into the wall there is movement suggesting there may be rot in the timbers or the hinges do not screw in very far.

Cracks in the wall are letting a lot of water in, would have been better if only one side was plastered because the timbers could have a chance to dry out.

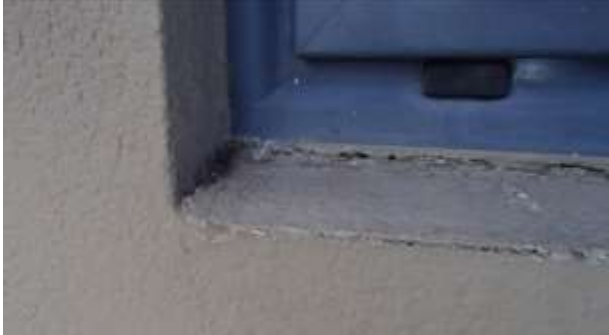
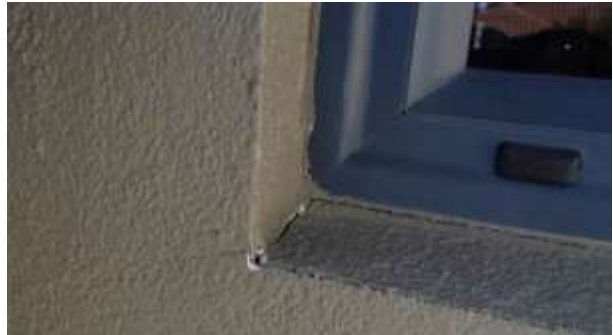
Plaster sills are in poor condition and need urgent repair.

The sills to the windows need to be replaced and all cracks repaired; urgently

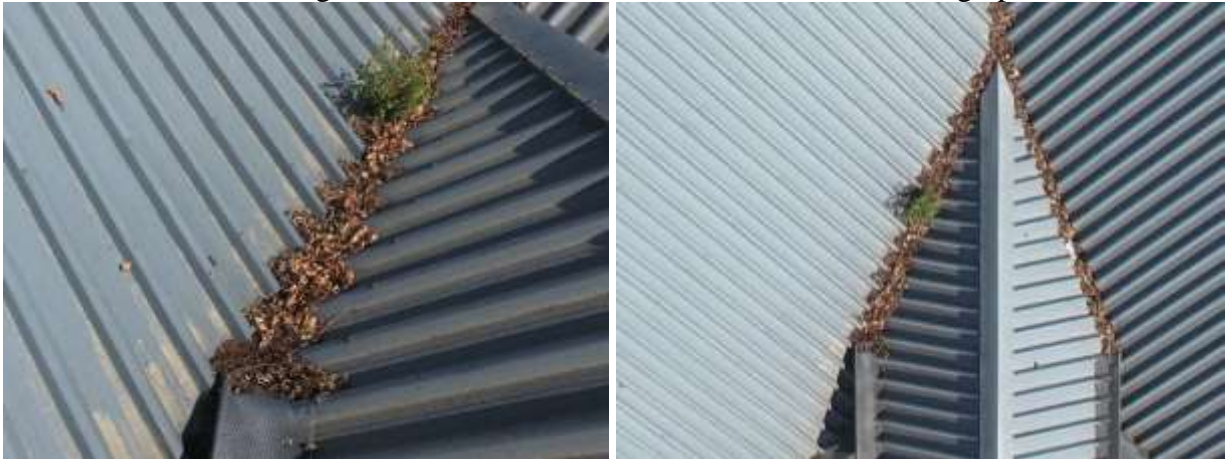
It has hips, valleys, ridges and gables with leaf guard on the outer gutters but not on the valley gutters. These are blocked with leaves from the large trees in the adjacent properties and will need to be kept clear and blocked valley gutters restrict the water flow which can cause the gutters to overflow, this is typically inside the house.

There are a lot of leaves in the valleys over the entrance and a plant growing

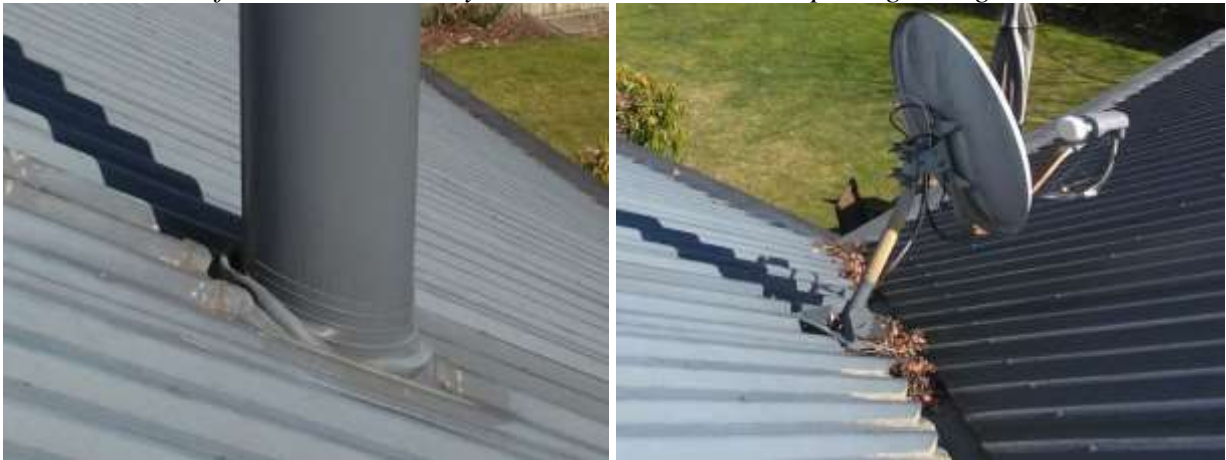
Good flashing to the chimney but will not comply for a replacement fire. more leaves in the valleys gutters

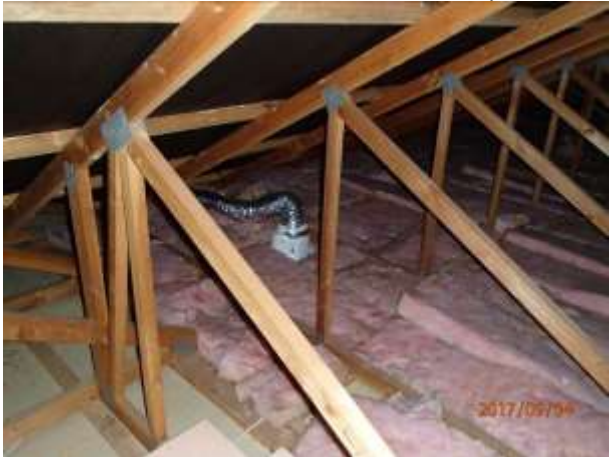
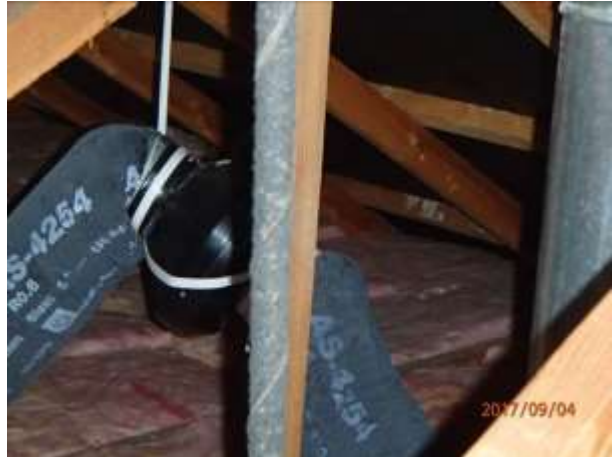
A heat transfer system has been installed to take excess heat from the lounge and duct it to the bedrooms. When the duct leaves the fan unit there is a sharp bend which will greatly restrict the air-flow.

Bathroom extract duct to outside. Heat transfer has a bend that is probably restricting flow

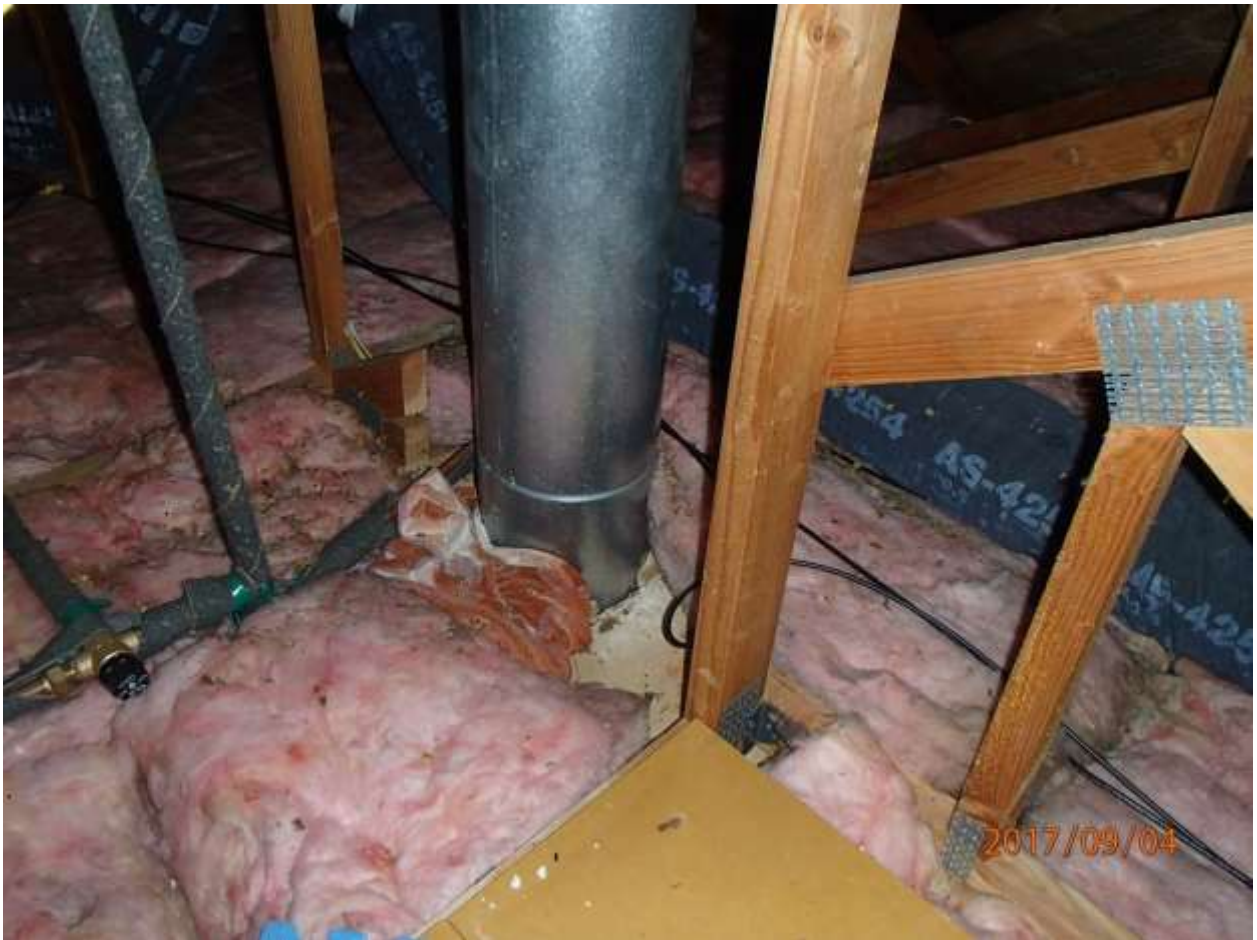
It looks like a towel has been jammed around the chimney flue so the reason for this should be sorted out but of greatest concern is a significant roof truss has been cut out to allow the passage of the flue from the fire. This will need to be inspected by an engineer and a repair designed and installed. When the replacement fire is installed the flue may be in a different place and may allow an easier repair to the flue.

This is of significant concern. The end of the truss has been cut out for the flue. I do not know what the towel is for. I can see nothing supporting the flue. This installation should not have been approved by council.

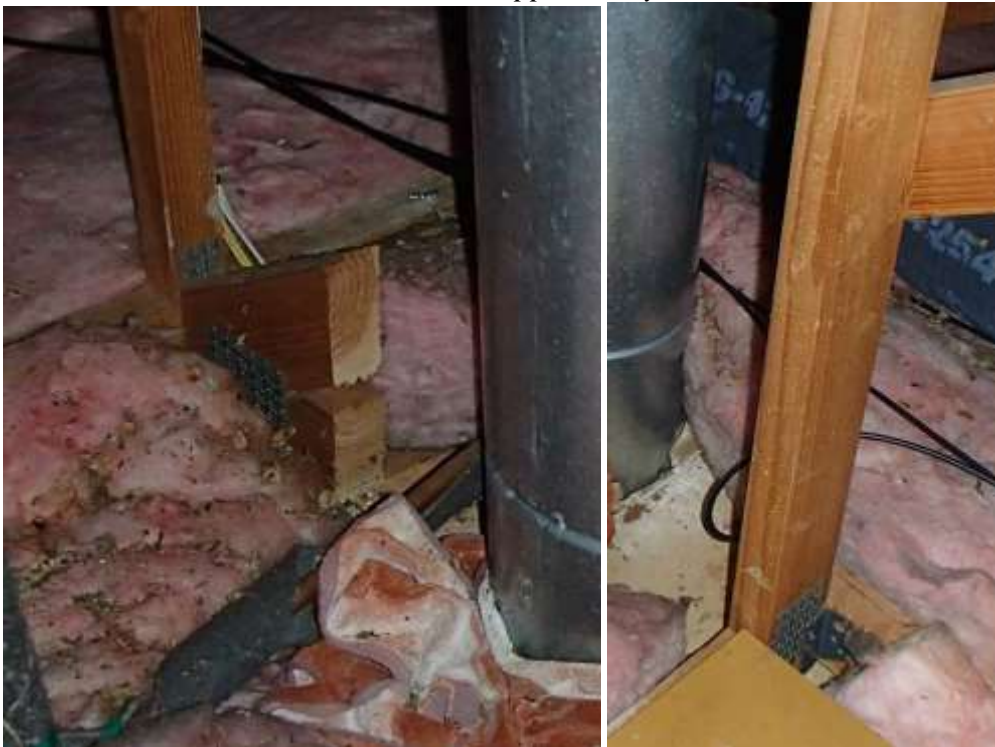
Truss bottom and top chord just cut out. Bottom chord supports another truss which also supports the header tank platform.
