Residential property inspection report.

Inspector/s: Keith and Bronwyn Langham, ASAP Building Inspections Ltd.

To carry out a pre purchase inspection of the property at Home at last and then, provide a written report on its current condition. We have not inspected or reported on minor damage, wear and tear etc and have not reviewed the council files.

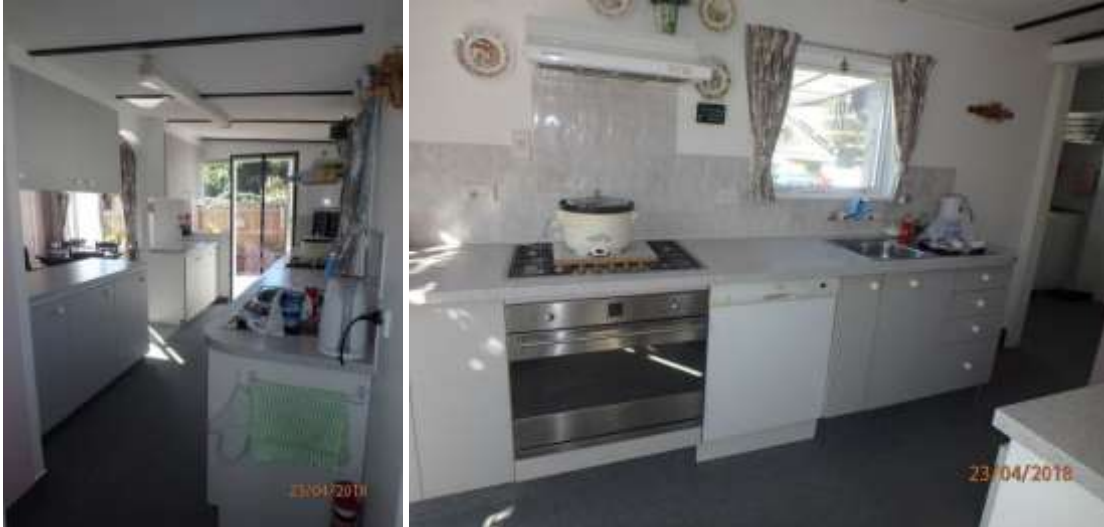
**Detailed report;
Kitchen: east corner.**

No significant faults or elevated moisture readings found.

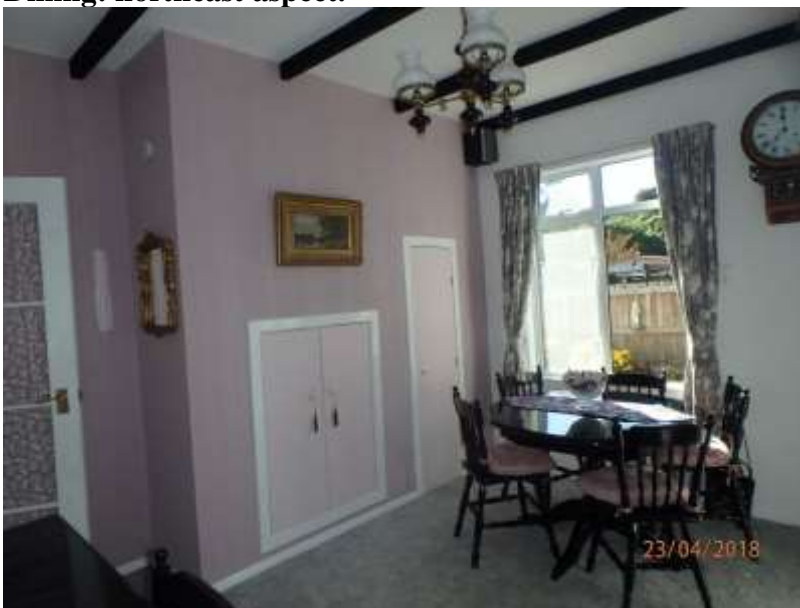
Dining: northeast aspect.

The ceiling is about 2.6 m high and has stained joists under the sheet linings. There is a patched area of ceiling in a small gap between one of the joists and the wall adjacent to the lounge fireplace.

There is an uneven gap over the door into the lounge and the door rubs on the carpet when wide open. There is a sheet join crack under the wall paper above the door.

The floor in this room is a bit creaky and tends to drop off away from the fire place area.

No elevated moisture readings found.

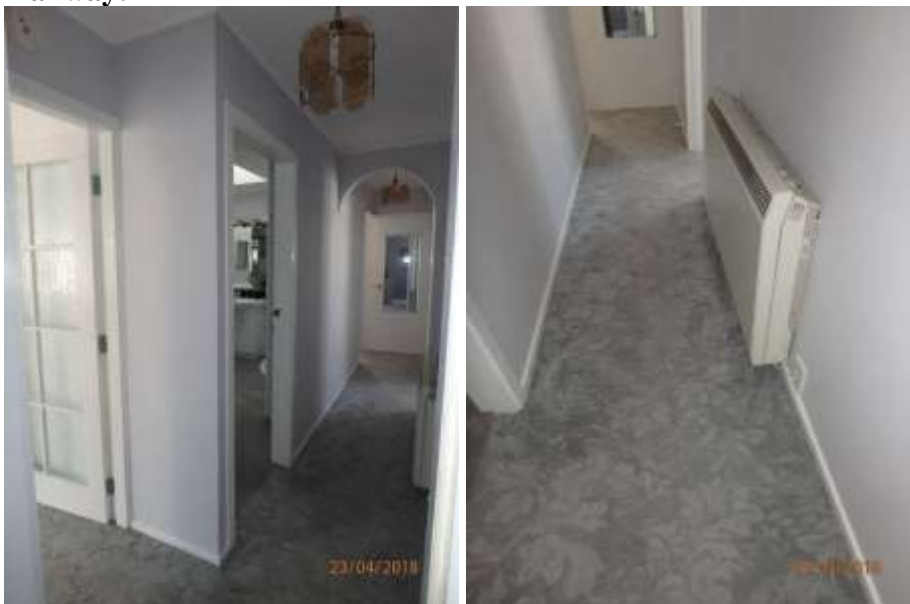
Hallway:

Our metal detector was activated and moisture readings in the wall linings were all above 70 suggesting something under or in the paint is affecting both meters. Readings in the skirting, including on the wall adjacent to the shower were all between 17 and 20, also probably being affected.

No significant faults found.

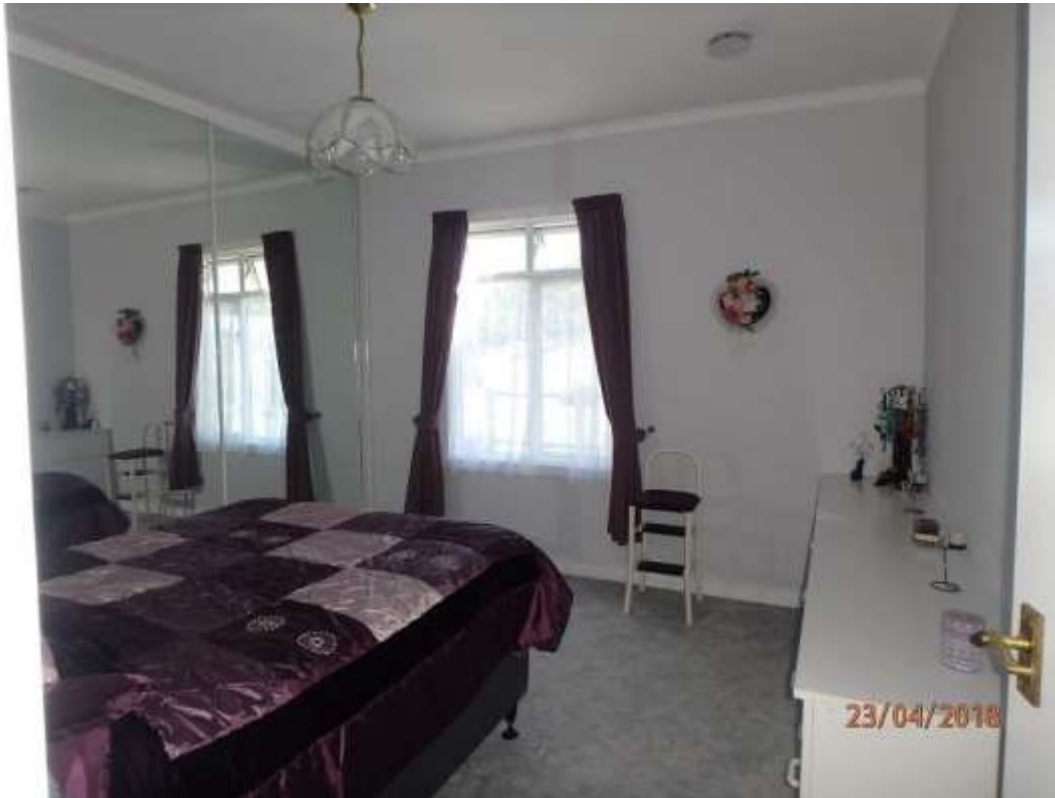
Bedroom one: west corner.

The large wardrobe with mirrored sliders runs the length of the southwest wall. The sliding door does not fit plumb up the exterior wall and rolls open about 40 mm when closed due to the slope in the floor.

No elevated moisture readings found.

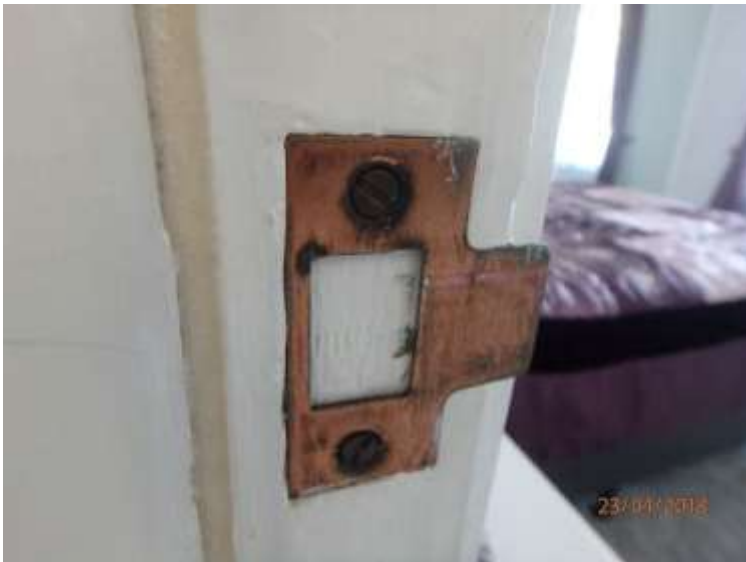
Has not been housed out for the latch

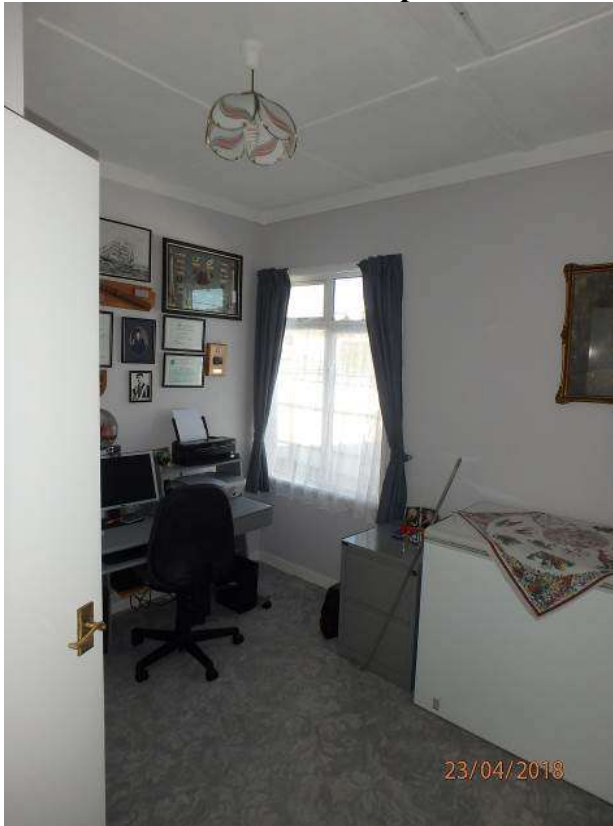
Bedroom three: southwest aspect.

The wall between this room and bedroom 2 is very close to the left side of the window, probably not its original position, and may have been relocated to make this room a little smaller. The wall lining has just been butted up to the architrave.

The wallpaper up the corner of the robe is quite stressed. This may have occurred when the papering was done but more likely it has been caused when the re-piling was carried out to the house.

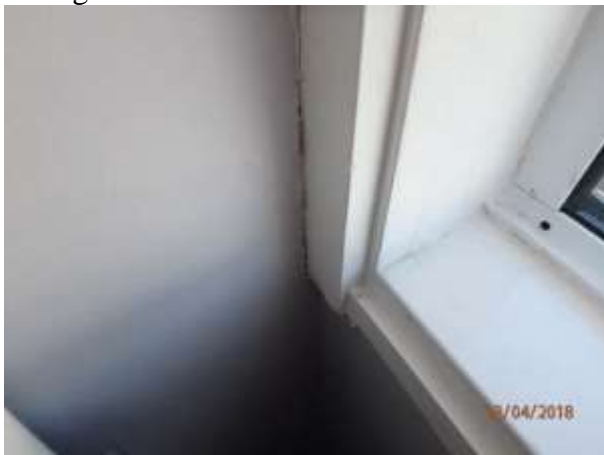
*The dividing wall is hard against the window.
Not original in this age house.*

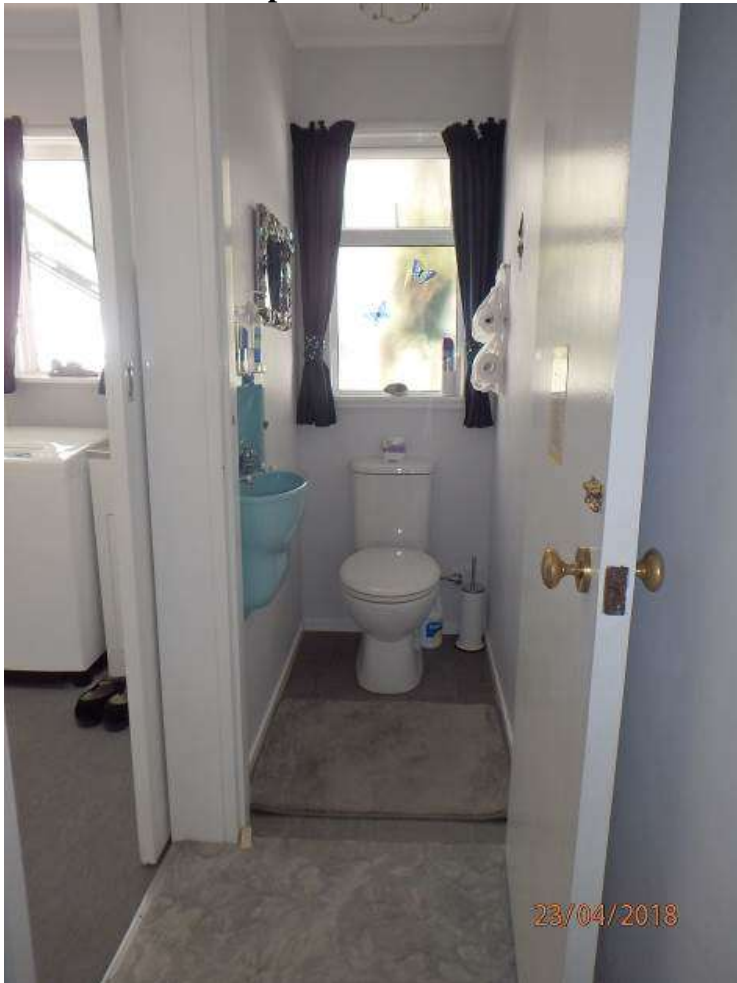
Toilet: southeast aspect.

Cold water pressure at the basin was quite a bit lower than the pressure at the hot tap and continued to drip once turned off.

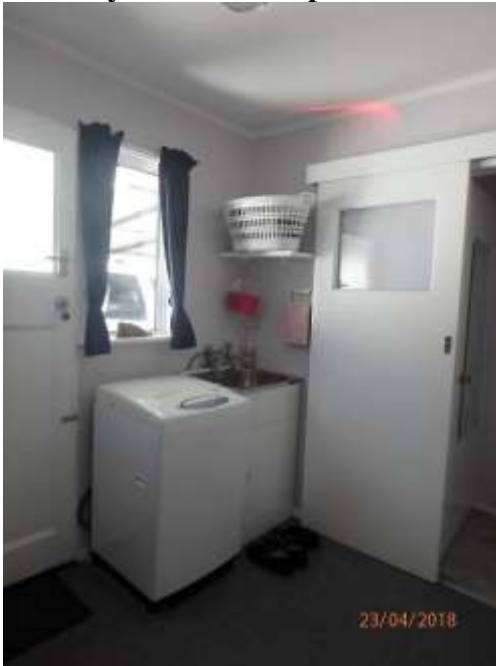
Laundry: southeast aspect.

This room has a fixed glazed window and a timber door with glass insert. The exterior door springs on the jamb. The edge of the door stop up the hinged jamb has had the paint removed to try and alleviate the problem. The back edge of the door needs to be angled off with a planer. The ceiling looks like Pinex sheet with PVC jointers.

There is a metal cabinet with stainless steel tub and space for a top or front loading machine. The cabinet doesn't seem to be secured in place. There is a gap behind the tub due to the water pipes to the washing machine and also a gap beside it. Both should have sealant between the tub and the walls.

There were no elevated moisture readings found in the interior wall adjacent to the bathroom shower. The small piece of skirting and the bottom of the door jamb into the hall look like they have been water damaged at some time but were currently dry. This may be damaged from an earlier shower.

The wall papering around this corner of the room is stressed.

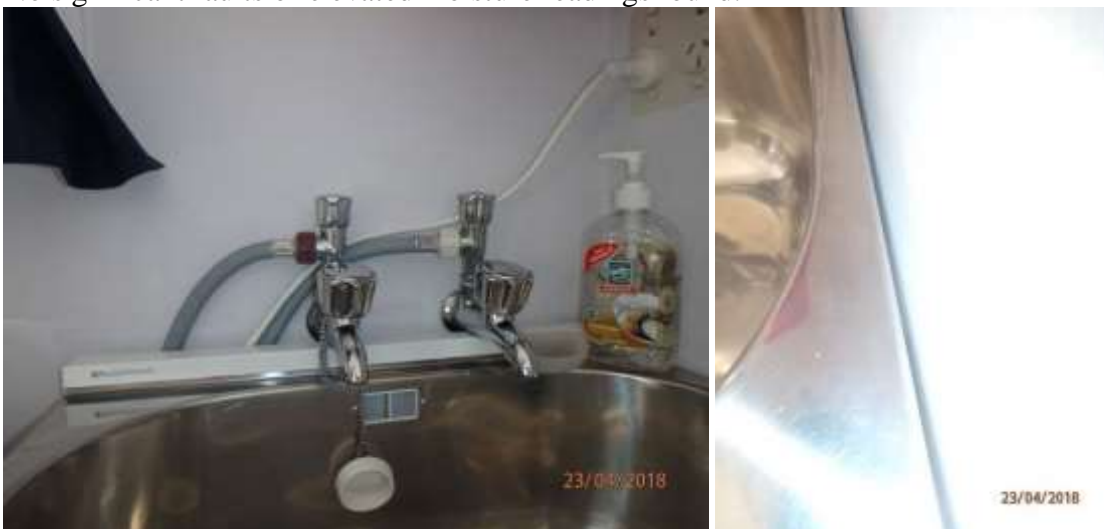
The tub is not secured or sealed to the side wall.

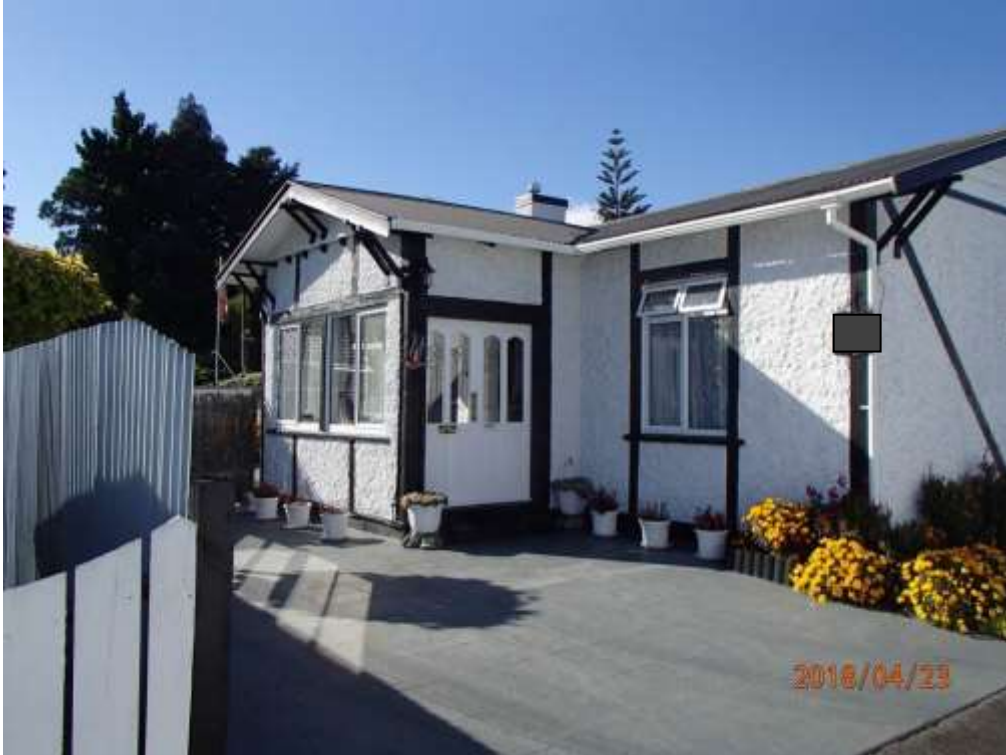
Northwest

Separation between timber facings and the plaster which will be allowing water in but this does not appear to be causing damage at this stage. That said these gap should be sealed to prevent water ingress.

Some of these facings are starting to rot and cup due to the extreme heat so will need to be replaced in the not too distant future. If you do replace the facings make sure the timbers you use are dry and paint the back side.

The sill to the window to that was once the open porch is starting to fail, you may be able to restore it but if left it will rot if it has not started already. The head across this window is way out of level but appears to have been like before they plastered the house.

On the northern corner the facings are rotten around the low fence and garden tap area.

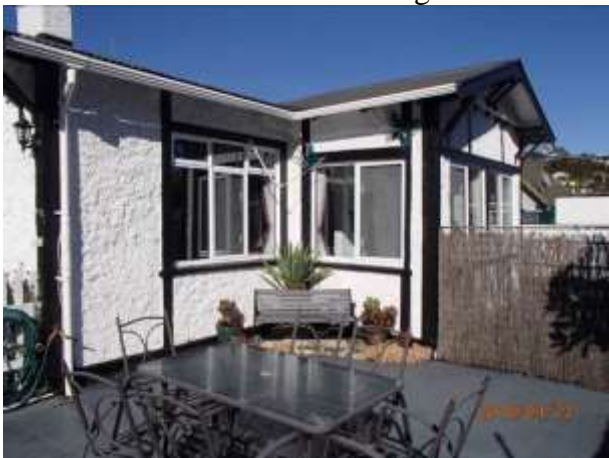
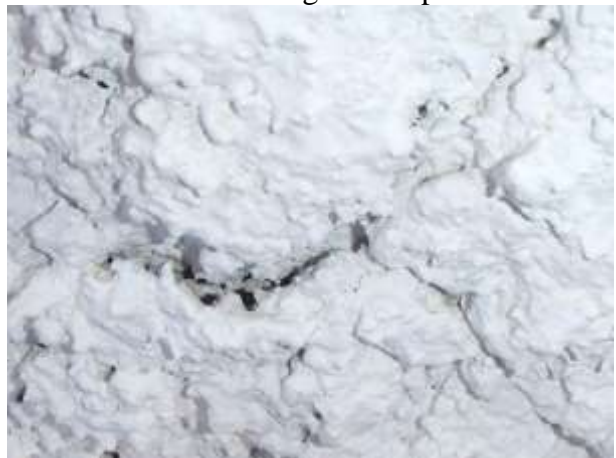
Despite numerous coats of paint there are still unpainted areas.

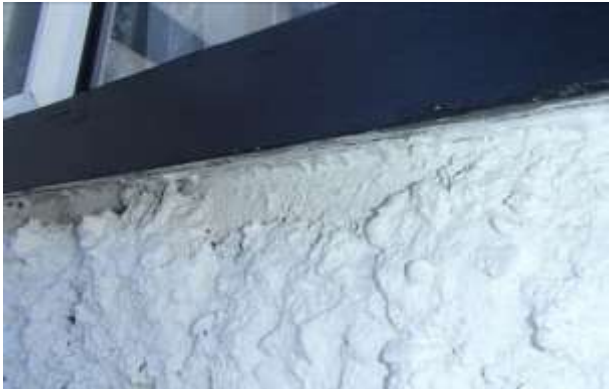
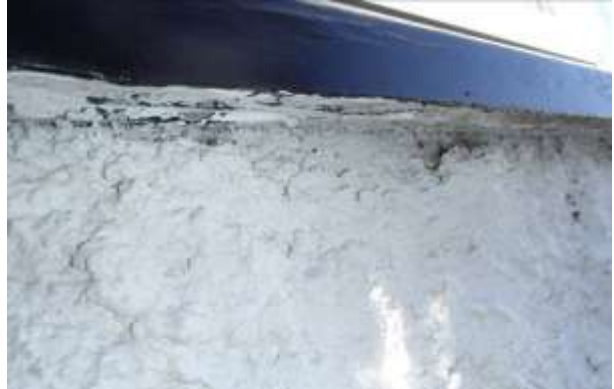
Difficult to tell what the plaster is applied over but it does not look that well done

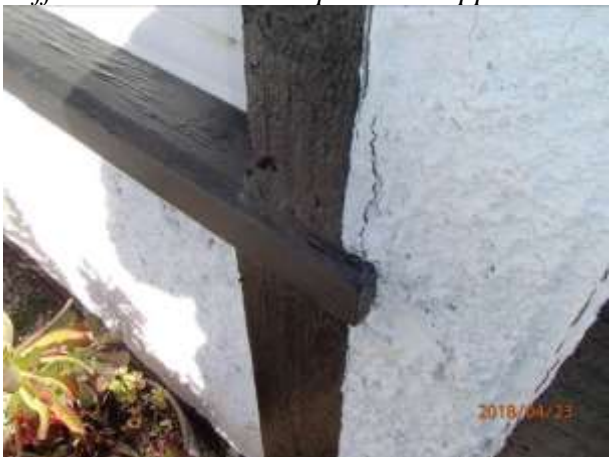
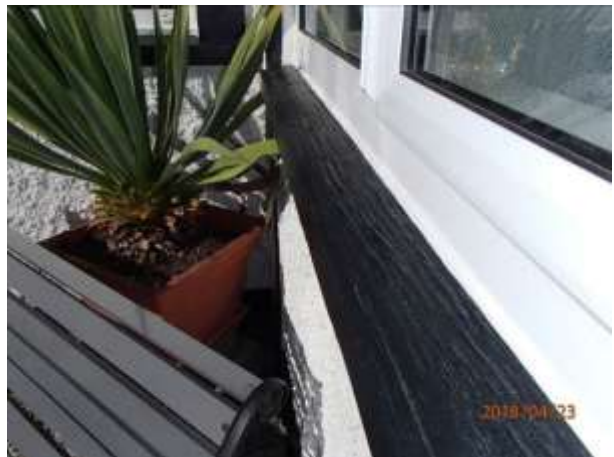
This facing should be replaced

window sill with blistering paint needs some work

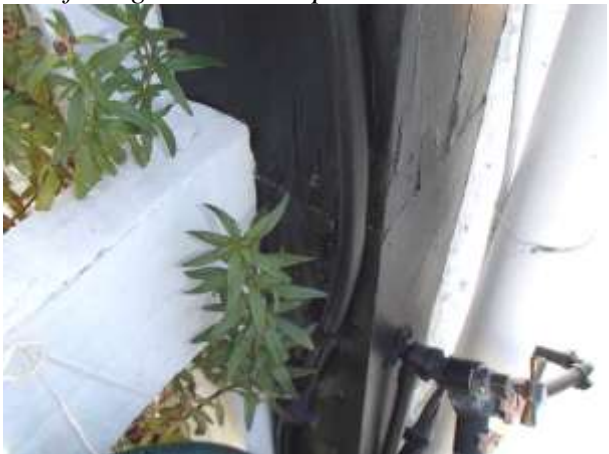
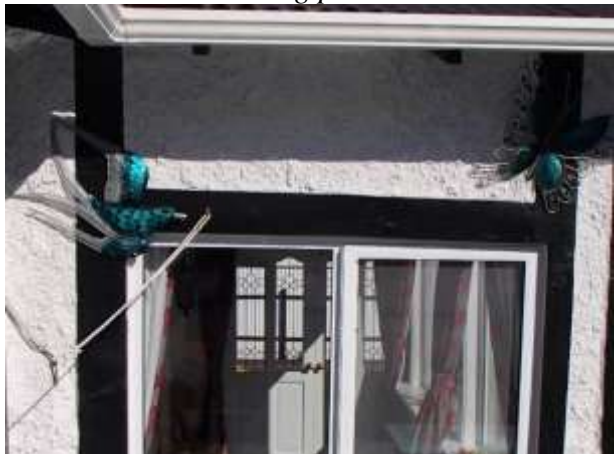
Impossible to see but this area is rotten. The out of level window has been this way for a long time

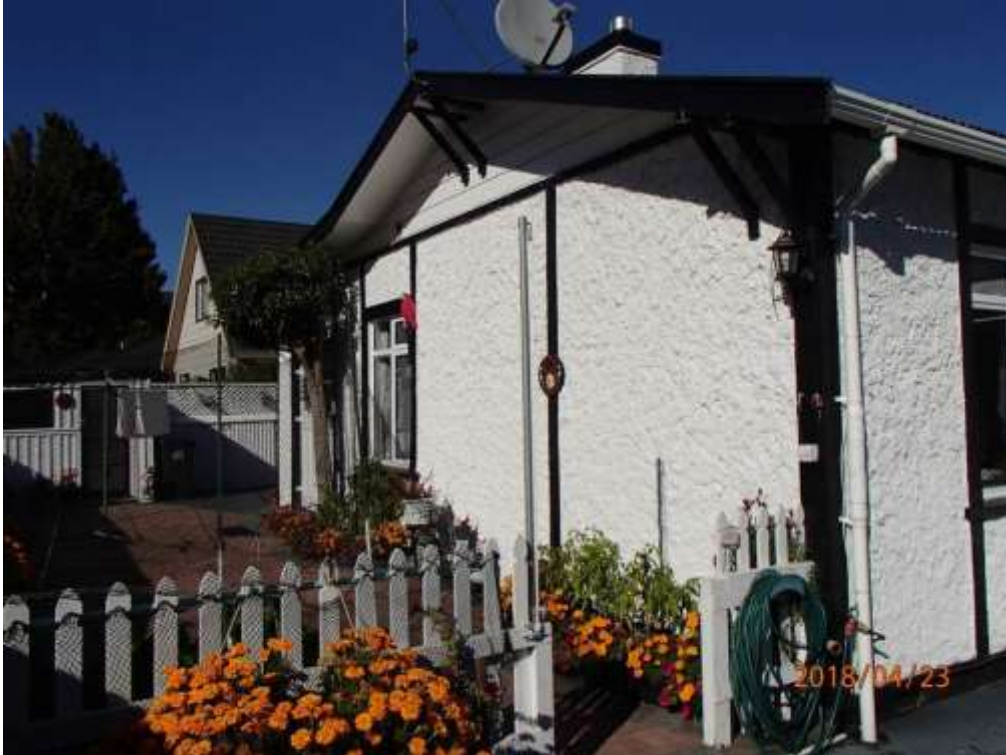
Northeast

A horizontal batten below the weatherboards and across the top of the plaster should have had a head flashing over the top the same as the windows. This batten has pulled away from the wall at the back kitchen door end.

The timber facings on this wall are also starting to rot especially near the bottom and the paint is blistering and failing where the facings meet the sills.

The back door step to the kitchen door is much higher than it should be but there is some weatherproofing in place.

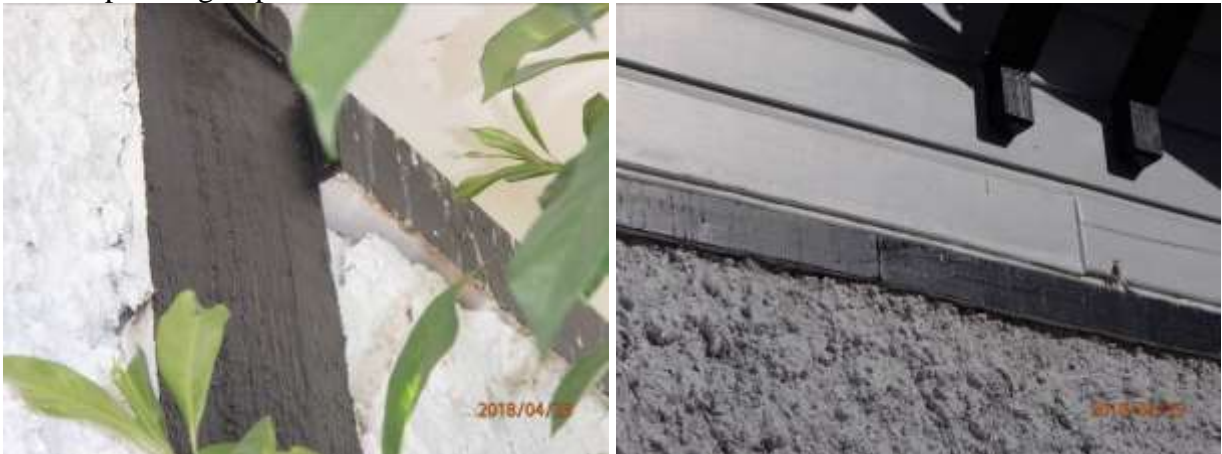
The door end of the horizontal batten is twisting out and there is no head flashing

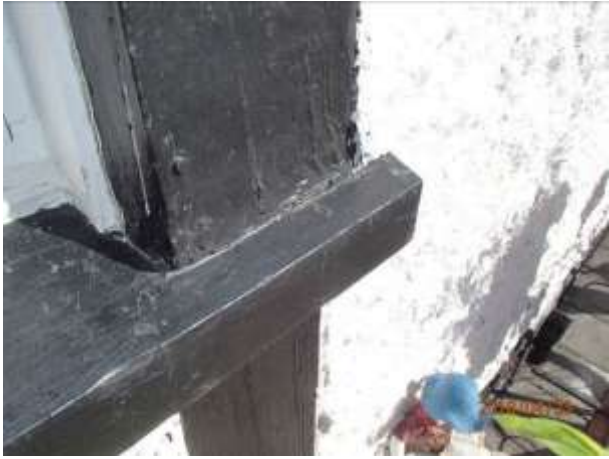
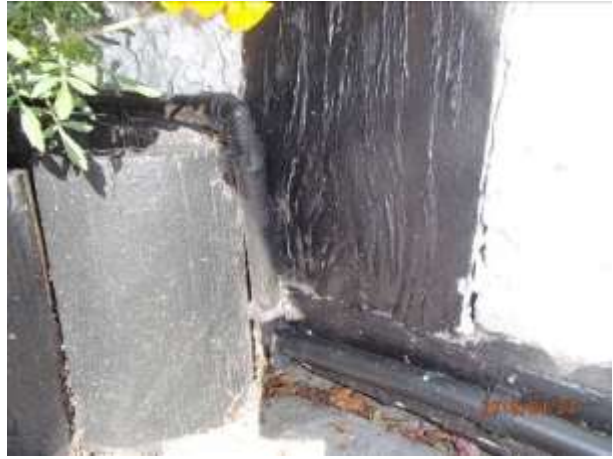
The bottoms of the facings are all starting to fail.

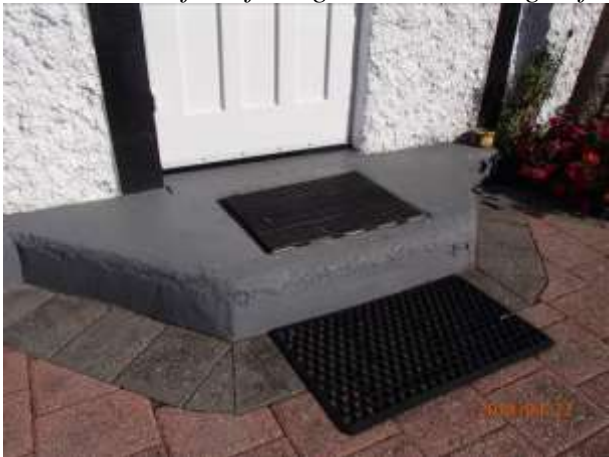
This step is very close to floor level

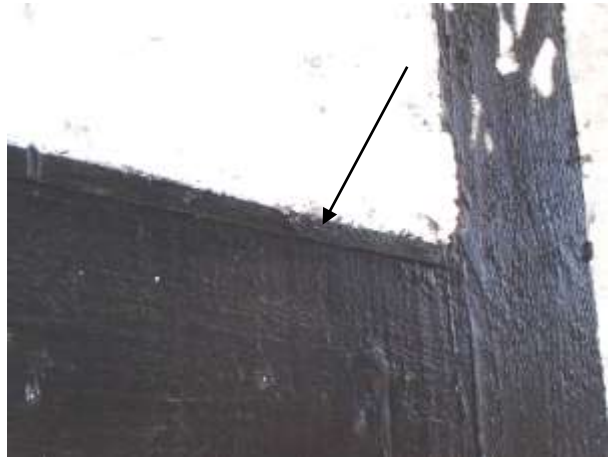
a flashing to a horizontal batten over a window.

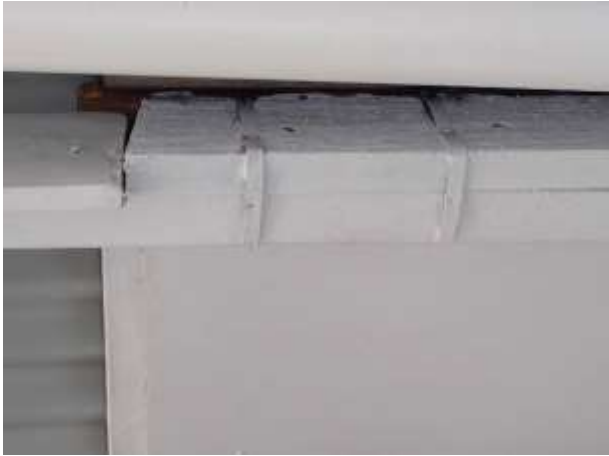
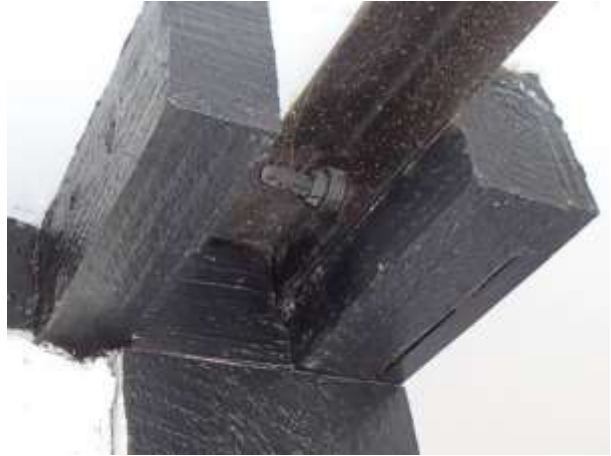
The top end of the carport rafters are not that well fixed.

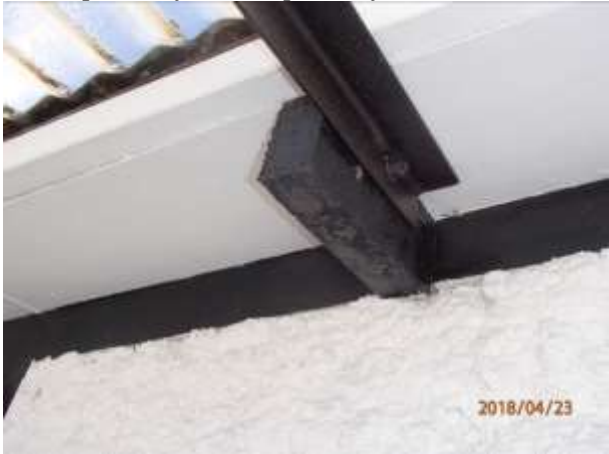
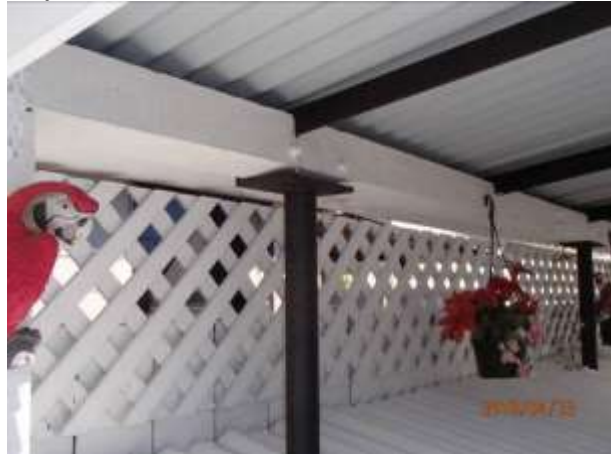
Just one bolt to an undersized steel angle. The outer end is better supported

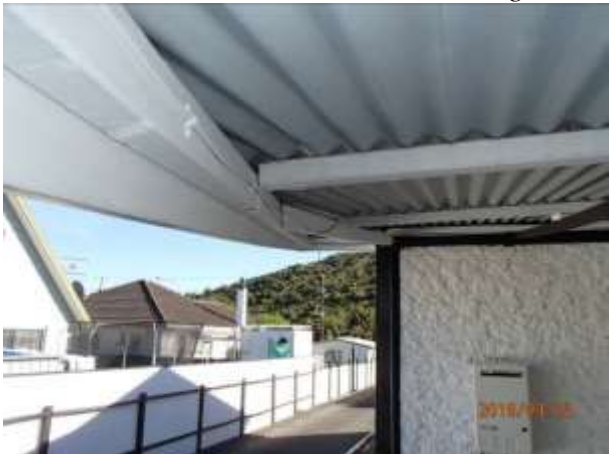
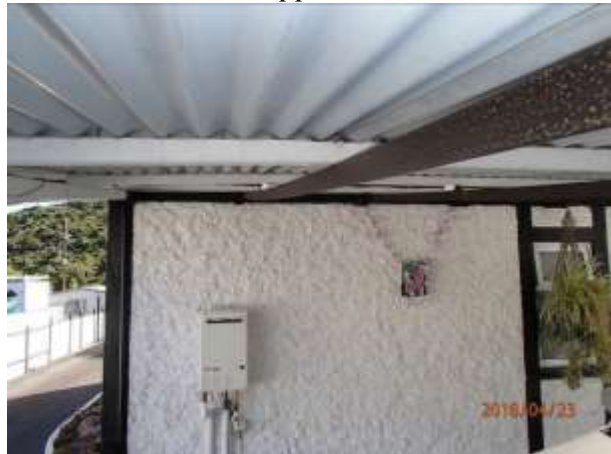
The structure appears to held up with good luck rather than sound practice.

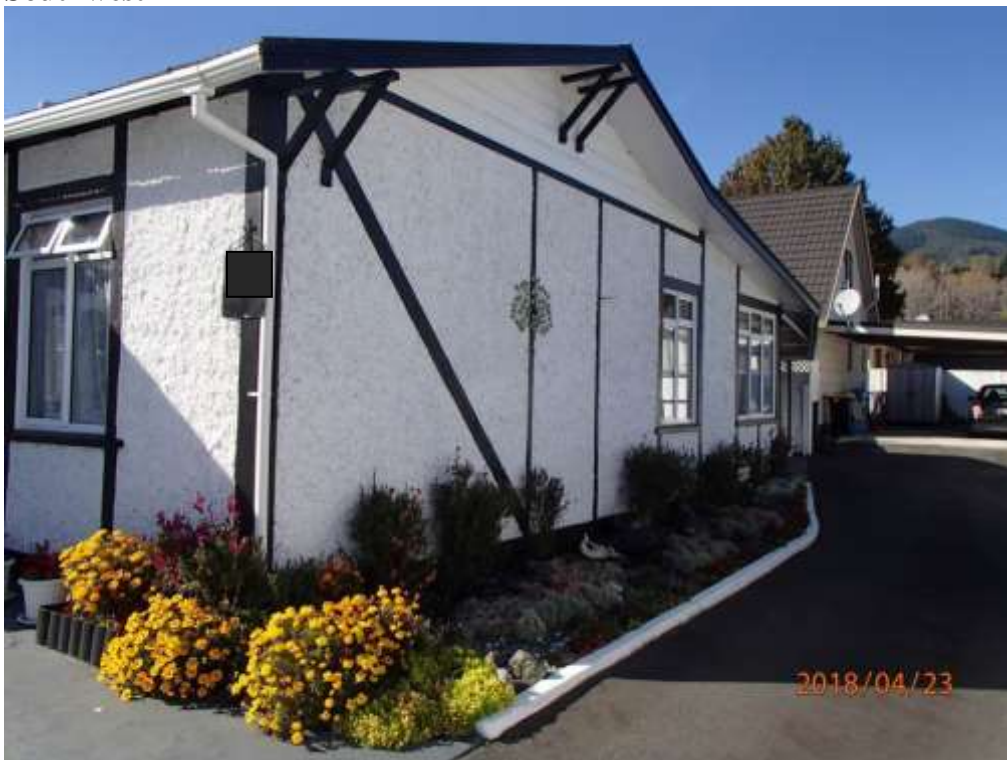
Southwest

Decorative timber frames are added to assist with supporting the outer rafter of the roof but at the top they are no longer touching the barge board.

Again there is no head flashing to the horizontal batten.

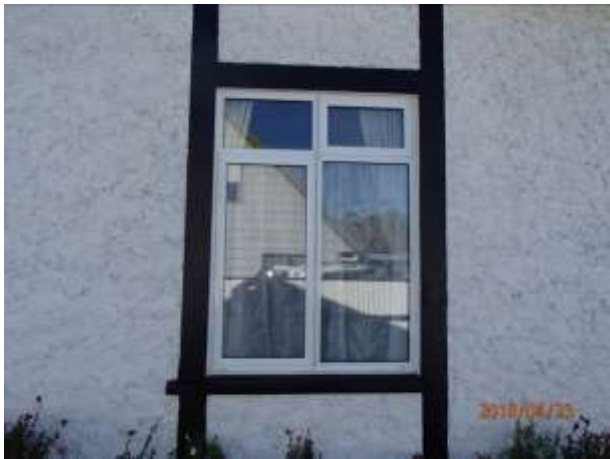
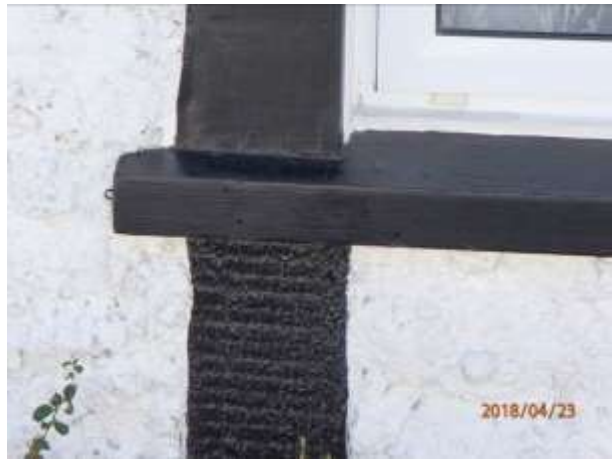
This window has a combination of old and new facings. If you paint them a lighter colour the right texture will be even more noticeable.

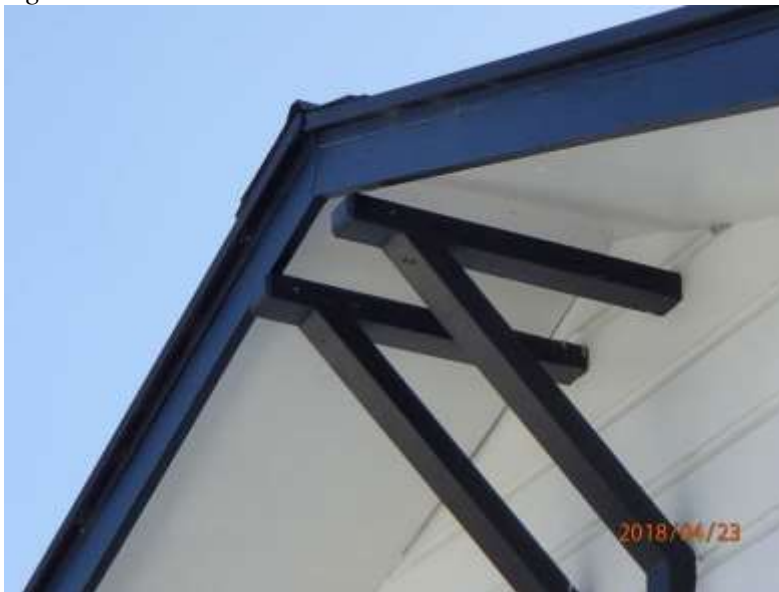
The rafters supports do not touch the barge rafter

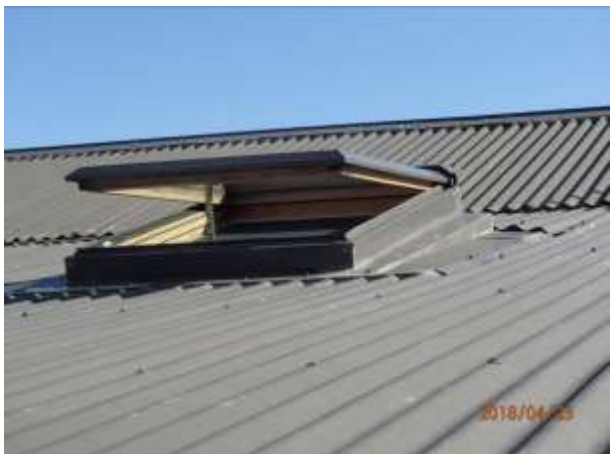
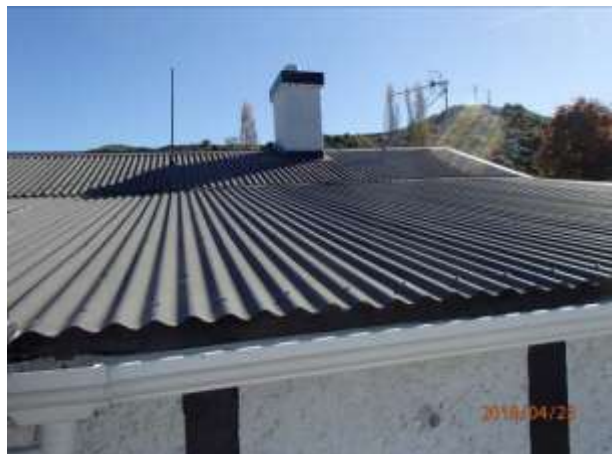
The roof is quite tidy and well flashed. Lichen is building up and should be treated

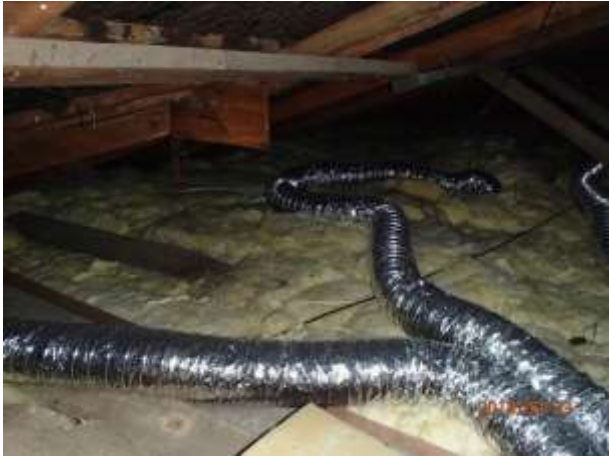
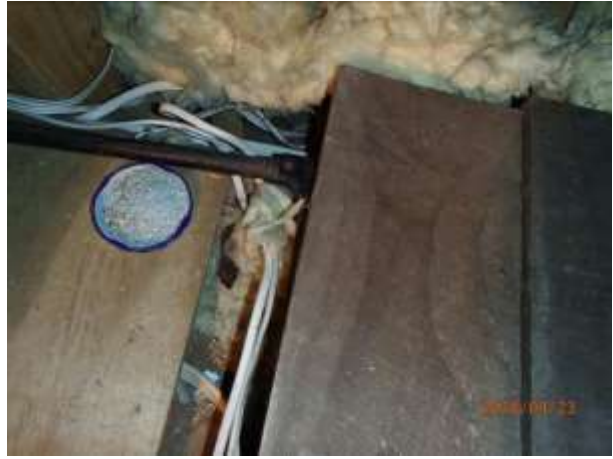
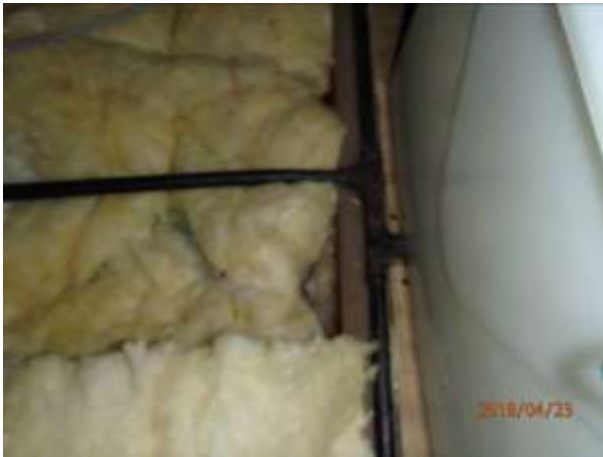
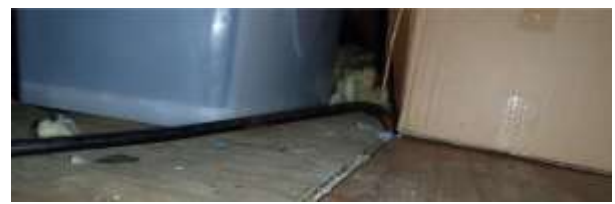
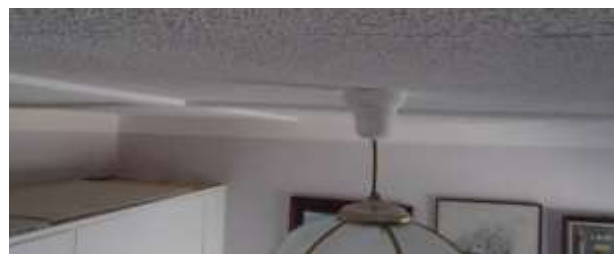
Steel conduits appear to still be in use; images show the conduit in the roof and the light below

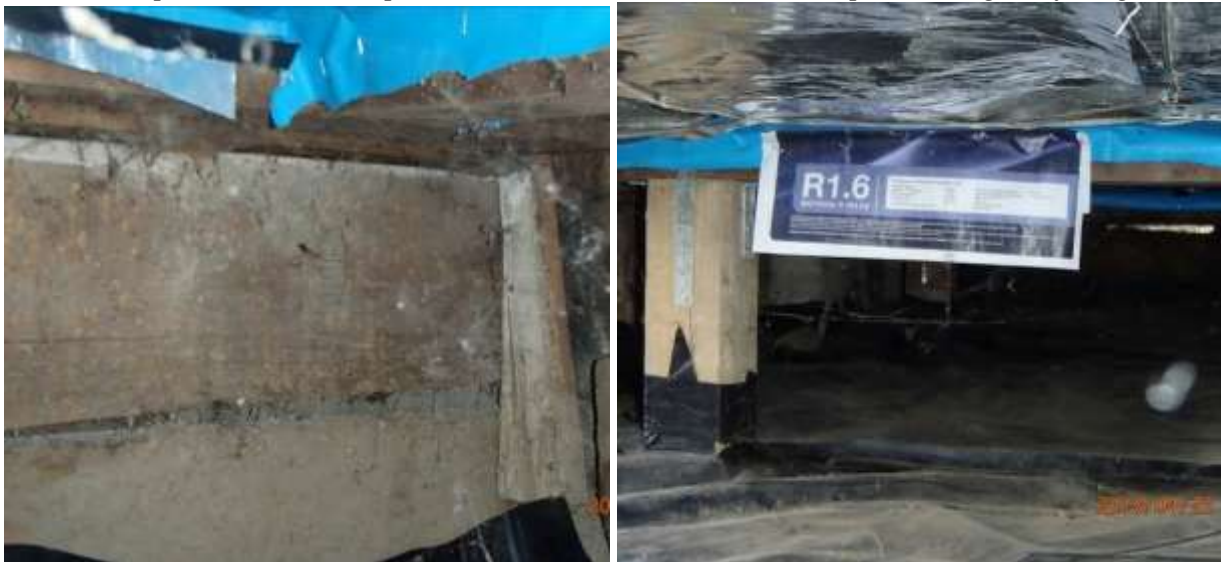
The plastered sections have timber boards on the inside that are suffering borer damage.

Borer damage in base boards behind plaster. R1.6 insulation
