Residential property inspection report.

Inspector/s: Keith and Bronwyn Langham, ASAP Building Inspections Ltd.

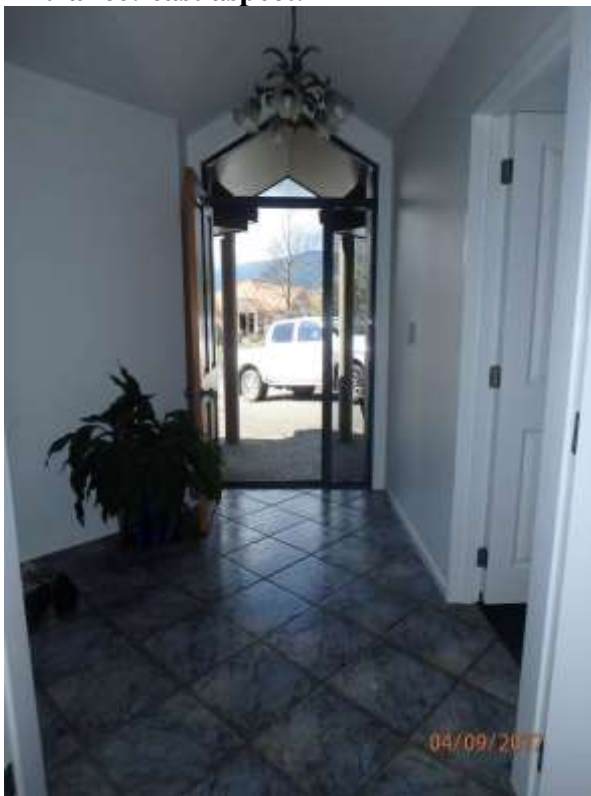
**Detailed report;
Entrance: east aspect.**

This has a timber door with a fixed glass side window in an aluminium frame. The doorway is covered by a portico and the concrete is a good step below floor level. No significant faults or elevated moisture readings found.

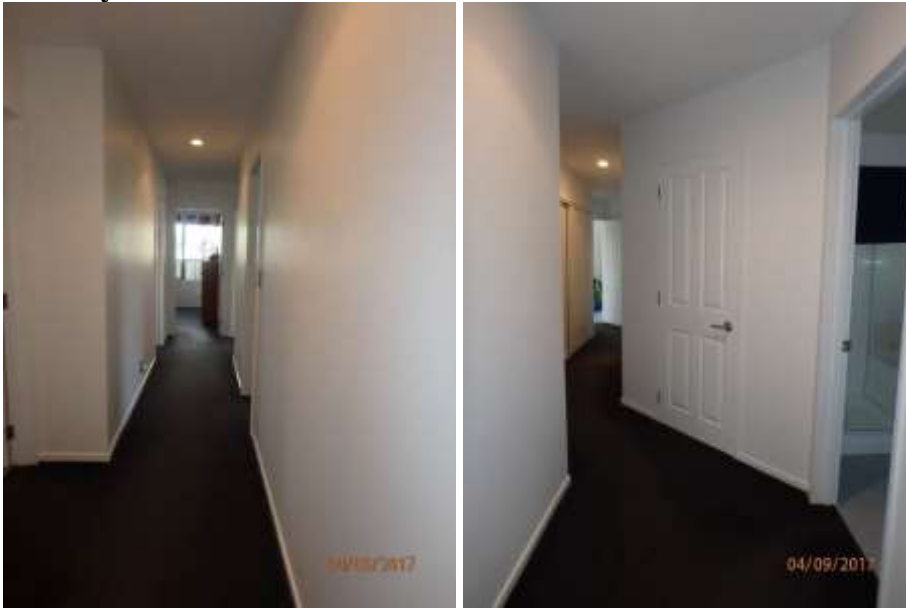
Hallway:

The hot water cylinder is the left end of the linen cupboard. It is dated as manufactured in 1998 and is a 180 litre low pressure storage tank. It sits on a framed timber shelf and only has one seismic restraining strap that is secured by standard Gib screws.

There were no elevated moisture readings found in the wall adjacent to the laundry, or in the small area of wall between the storage cupboard and the bathroom.

However, there were some very elevated moisture readings up to 67.5 found in the skirting inside the storage cupboard in the area adjacent to the front corner of the shower. The bottom of the skirting was swollen, a sign that MDF has been or is wet. Readings in the plaster board just above the skirting were only slightly elevated at up to 10.9. We suggest the bottom of the framing in this area of wall should be investigated further for deterioration. This may also be a good area to try to ascertain where the moisture is coming from.

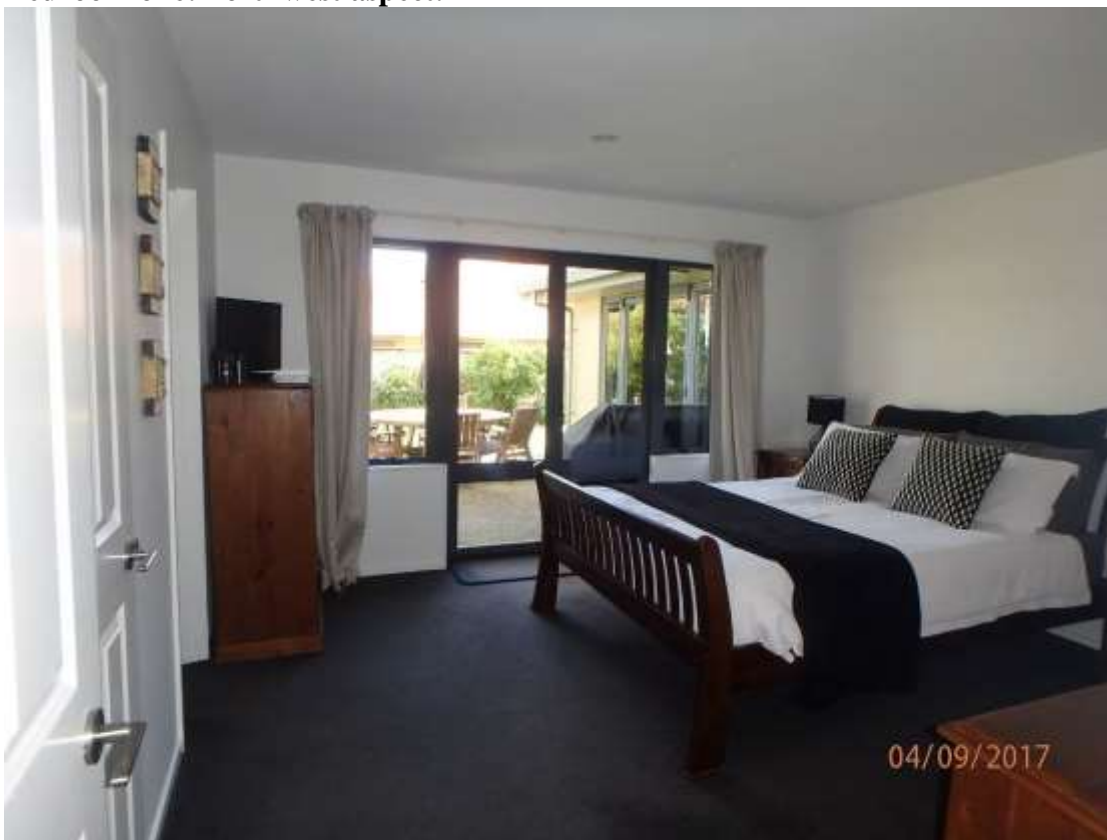
Bedroom one: northwest aspect.

This room has bi-fold doors with opening windows either side in the northwest wall. There is a bubble under the wall paper just above skirting near the internal door, on the wall adjacent to the hallway. As this is not near any sanitary fixtures it is unlikely to be moisture related and more likely caused by the paint over the paper. No significant faults or elevated moisture readings found.

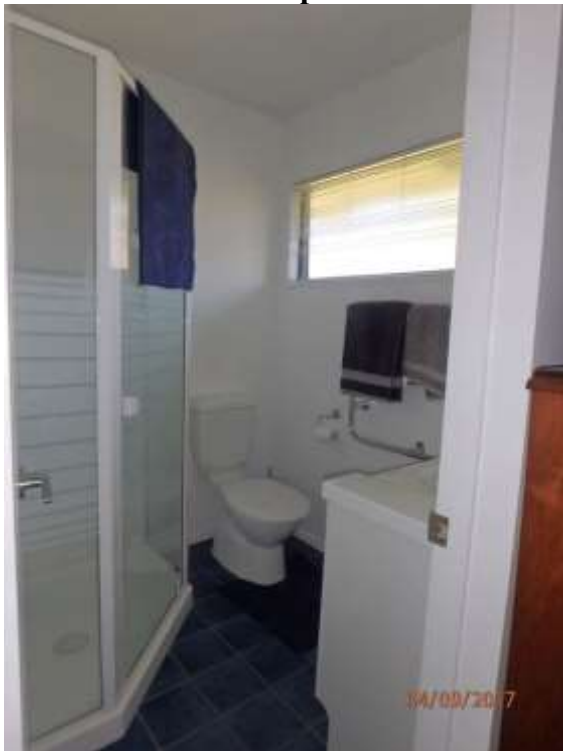
Ensuite: northwest aspect.

This room has an opening window at approx. 1500 mm high, a vanity, a dual flush toilet and a proprietary shower with acrylic tray, prefinished sheet linings to the walls and glass door and side screens.

The vanity unit has taps with flexible hose pipes and uPVC. The hoses are in poor condition and appear to have corrosion on their surface. Water pressure at the cold tap was very good but pressure from the hot tap was quite a bit lower.

Moisture readings were very elevated readings of up to 66 just above the skirting on the wall adjacent to bedroom 2 between the shower and the toilet. Readings in the skirting were also higher here at up to 21.8 along this piece of wall and the skirting looked swollen, thicker at the end closer to the shower.

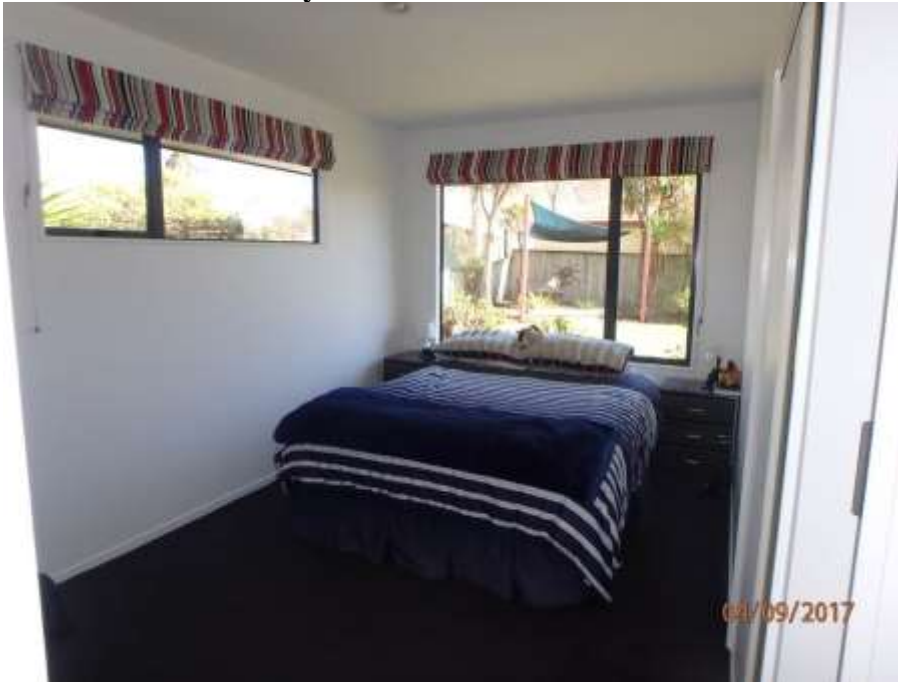
Bedroom two: westerly corner.

The larger window in this room faces northwest, the smaller to the southwest. There are repaired sheet joint cracks that run horizontally at each end of the northwest window sill and one that runs vertically under the right end of the southwest window. There were no elevated moisture readings found in either of the exterior walls and readings in the wall lining and skirting adjacent to the ensuite were not elevated. No significant faults found.

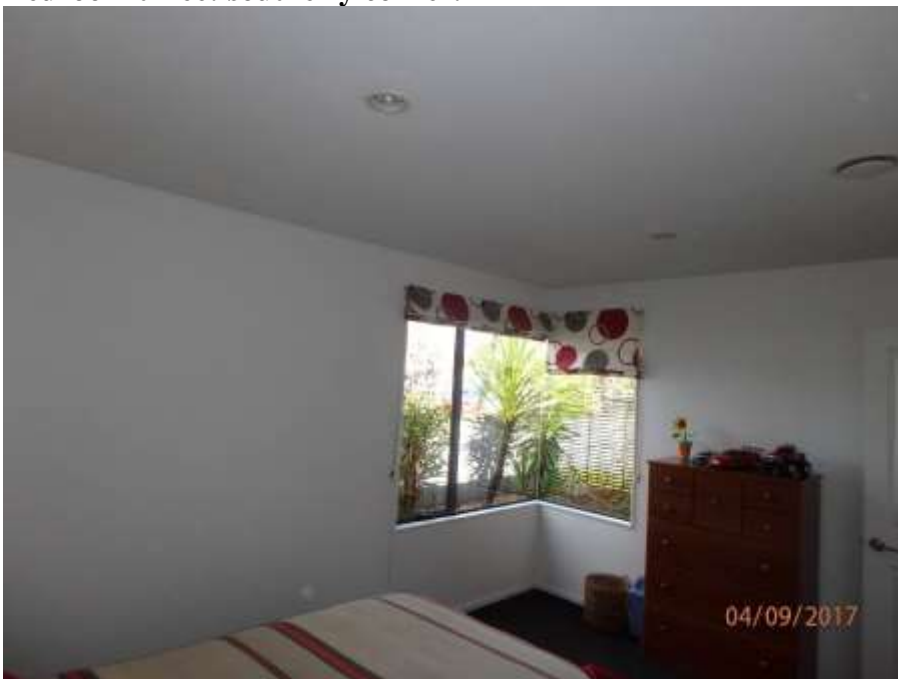
Bedroom three: southerly corner.

This room has a corner window in western corner where there is a step in the southwest wall. There were elevated moisture readings of 26 found directly under the right end of the sill on the northwest wall but readings in the skirting and the lower area of wall here did not appear elevated. Readings under the remainder of this window were below 9.8. There is a repaired sheet joint crack under this end of the window. The sills are not sitting flush where they meet at the mitre join in the corner of the window.

Moisture readings were slightly elevated at up to 16.7 in the skirting along the southeast wall and readings in the bottom of the plaster board along this wall were also up a little compared to further up the wall. These readings are not considered high but just noted as being higher than those around the remainder of the house and may be due to the aspect of this wall. Lowering the gardens outside may be all that is required.

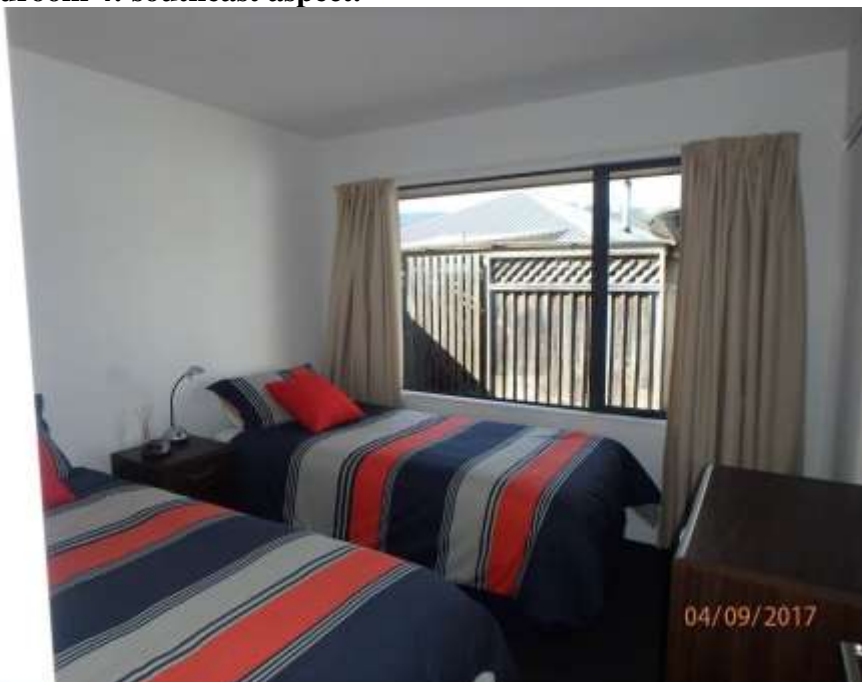
Bedroom 4: southeast aspect.

No significant faults or elevated moisture readings found.

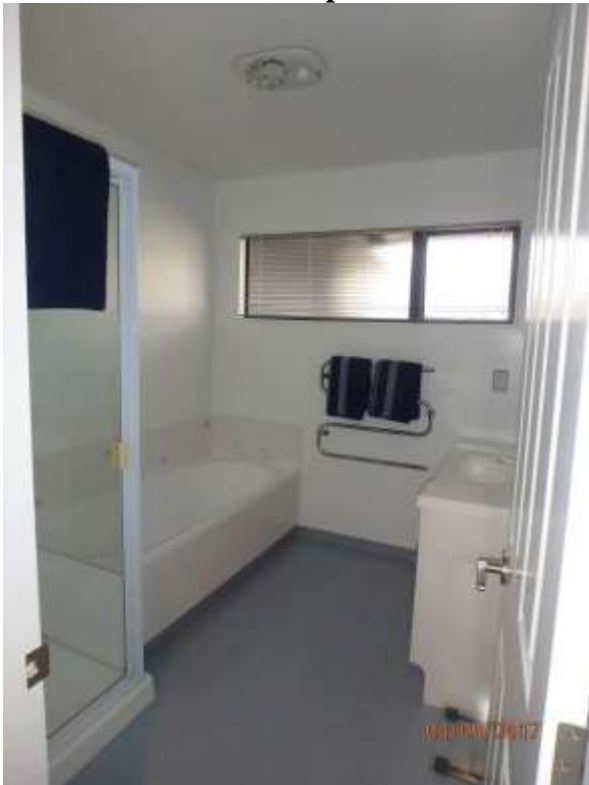
Bathroom: southeast aspect.

This room has an opening casement in the window which is approx. 1500 mm above the floor. There is a tiled surround around the top of the bath.

Sealant has been installed along the back and end of the vanity but the bottom edge of the mirror above the upstand is beginning to delaminate thus the blackened areas of the glass. Sealant put between the mirror and the upstand may stop this getting worse.

The vanity hoses are in good condition. The mixer is a little loose.

The bottom edge of the bathroom door binds on the jamb. This is likely to be due to swelling in the timbers between the door and the shower as elevated moisture readings were found near the shower with 30 in the coved area of the vinyl flooring and 66 in the bottom of the plaster board. The readings reduced moving toward the bathroom door.

This area is adjacent to the high readings found in hallway storage cupboard.

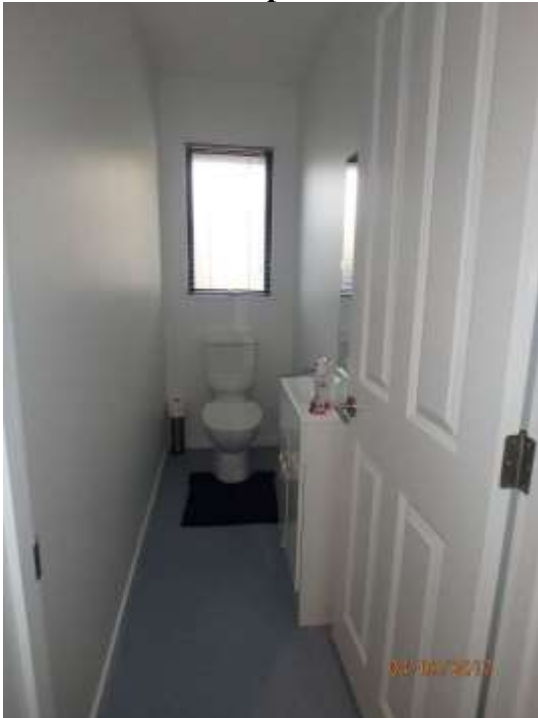
Toilet: southeast aspect.

This room has a dual flush cistern, a small vanity and an opening window.

The vanity top has its own up stand but there is no sealant between the back of it and the mirror. If water is splashed in this area it could run down the back of the unit and affect the unpainted plasterboard in the back of the cabinet. There is a chip missing off the corner of the melamine of the cabinet. The water hoses to the taps are in much better condition than those of the ensuite vanity.

No significant faults or elevated moisture readings found.

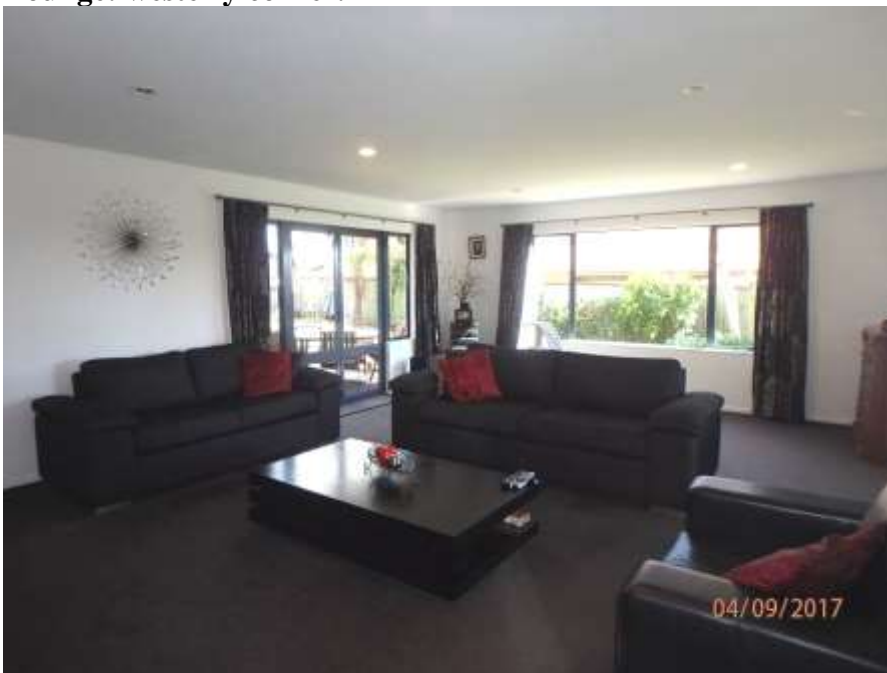
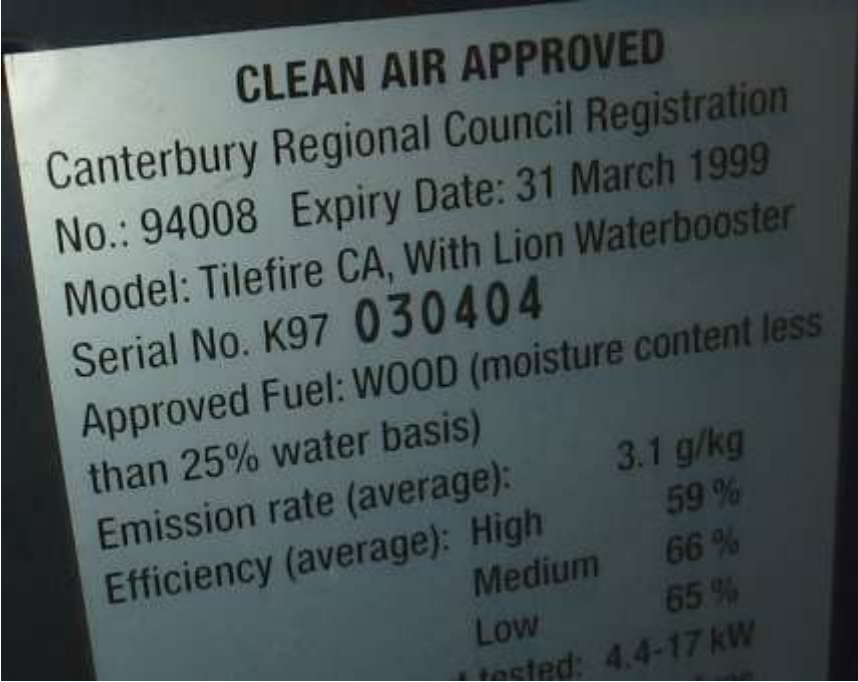
Lounge: westerly corner.

This room is open to the dining area and has double doors into the entrance foyer.

There is a bi-fold door and two opening windows in the southwest wall and a window with two opening casements to the northwest.

The freestanding Kent Tile fire is located at the end of the room adjacent to the HWC. There are pipes connecting the cylinder to the fire for boosting the hot water supply. From the label it appears the fire would have been installed between 1994 and 1999. The condition of the fire was not checked. As the property falls under the Richmond Air Shed rules and it appears this burner does not meet the current emission level requirements Building Consent is required to replace the burner with a clean air approved appliance after the sale of the house if a solid fuel burner is wanted.

We make note in the report under “roof space” of a problem with the installation of the flue for this burner in relation to the trusses.

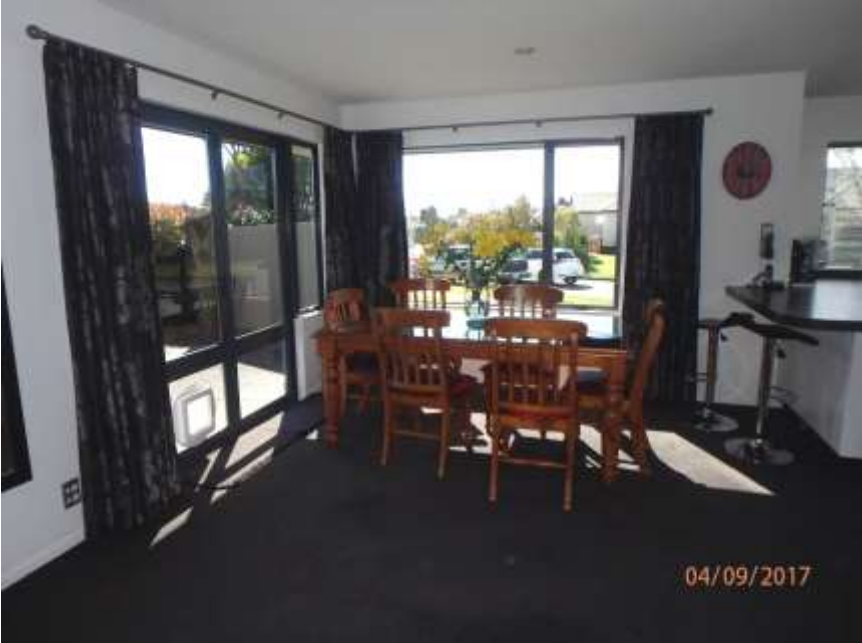
Dining: northerly corner.

This area is open to the lounge and the kitchen. There is a bi-fold door and two opening casement windows in the northwest wall and a window with one opening casement in the northeast wall. No significant faults or elevated moisture readings found.

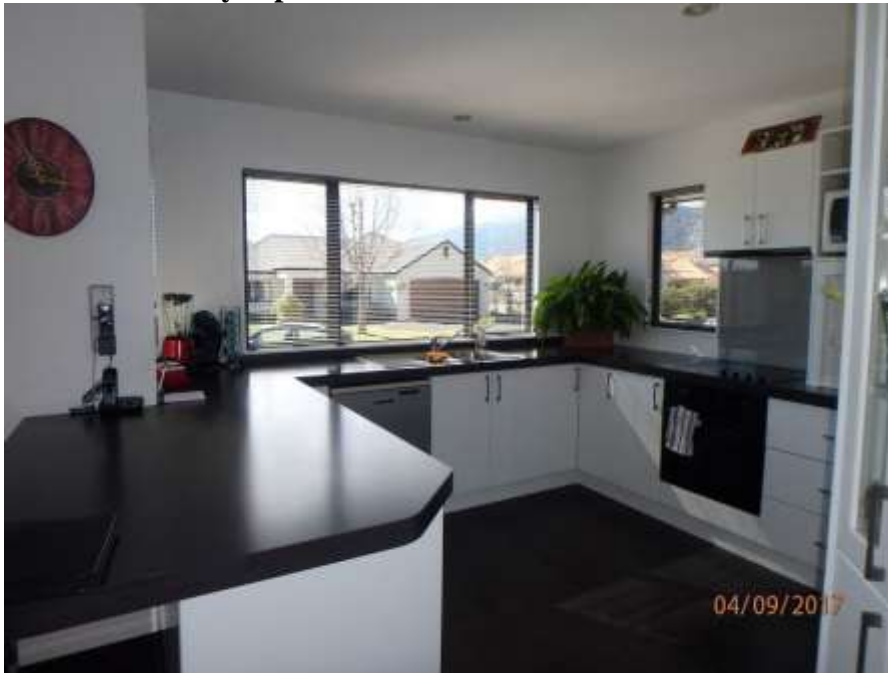
Kitchen: easterly aspect.

This area has the larger window in the northeast wall over the back of the sink bench and windows in both return walls.

It has Formica benches over melamine cupboards and there is a 1 ¼ bowl stainless steel sink, an under bench dishwasher, under bench electric oven, glass cooking hob with integrated range in the cupboard above and a standard width tall fridge space. The smaller sink has a waste disposal fitted to it. There is a glass splash back between the hob and the range hood; the sink bench has a small upstand up to the window sill.

The toe space edge of the cupboard panels either side of the dishwasher are a bit swollen from water damage and there is also some swelling in the bottom of the toe space under the sink. Moisture readings along the toe spaces ranged between 11 and 19, the higher readings to the right of the dishwasher.

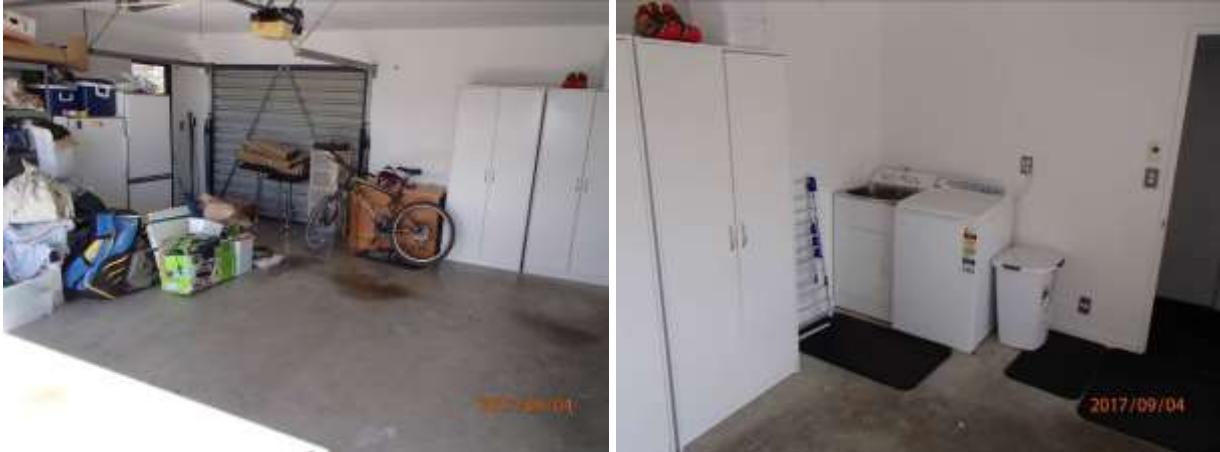
Garage/laundry

There is a double garage with internal access, the main door is a double tilting door with an auto opener and there is a single door in the back which is manually operated.

There is also a side door, an internal door a small office and the laundry in the garage.

The garage floor has a few fine cracks that are typically due to shrinkage of the concrete and do not pose a structural problem.

No significant faults or elevated moisture readings have been identified.

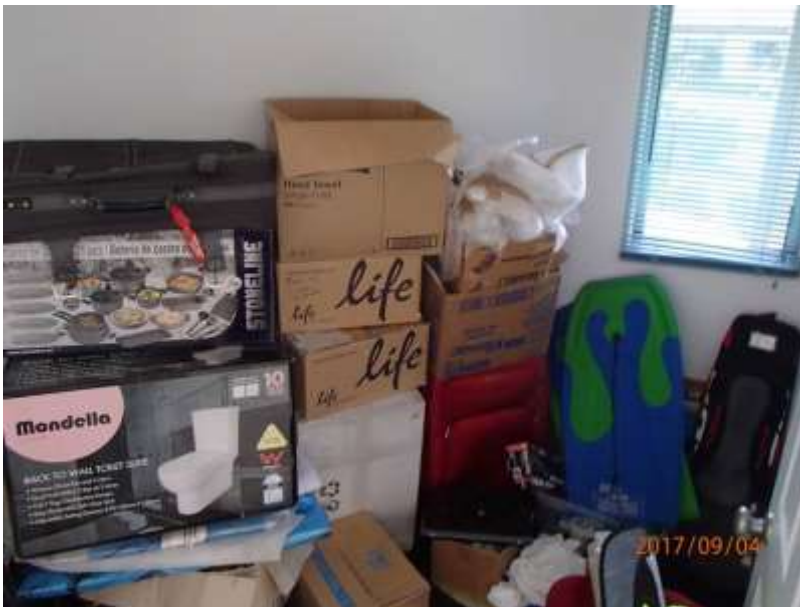
Office

In the corner of the garage is an office or storage room with the access hatch to the ceiling and the power distribution board.

No significant faults or elevated moisture readings have been identified.

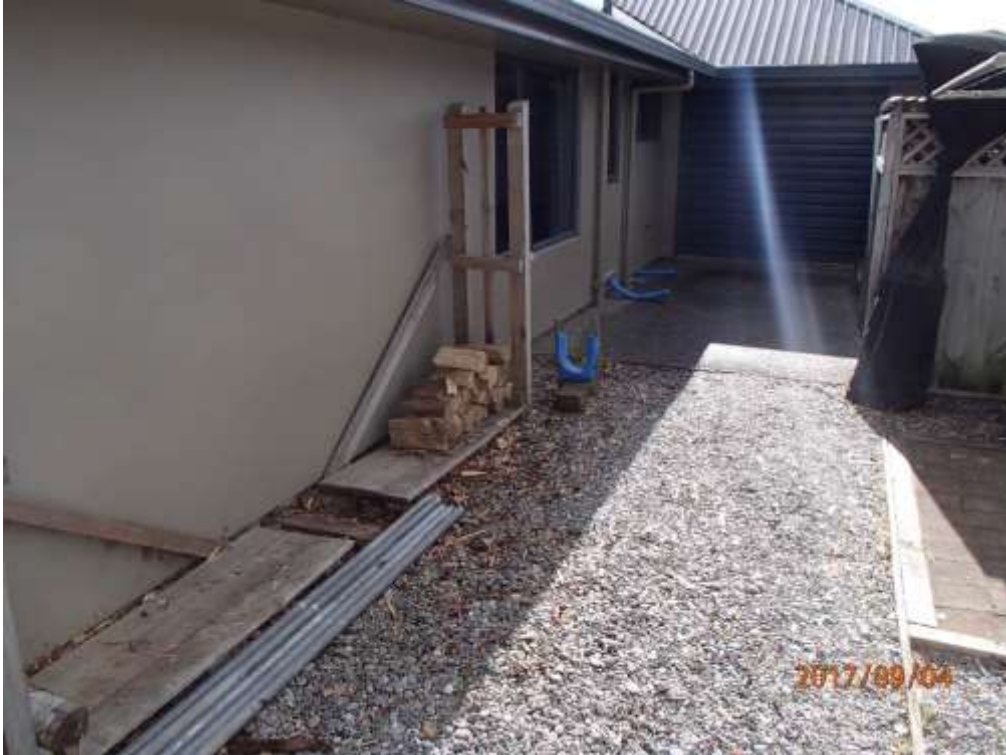
Southeast

This side as mentioned has a walkway through to the school. There is a bike shed and a steel storage shed along this side of the property and a single tilting door in the back of the garage to a paved area. This is the services side of the house with the clothesline and a side door to the garage/ laundry.

The plaster on this side is just dirty with a few fine cracks from the corners of the windows just time for a wash and fresh paint.

The exposed aggregate concrete paving is about 60 mm below the bottom of the cladding which is about 50 mm below the floor, not quite as much as suggested but it seems to be working well. A gully trap here is the correct height above the paving but the grill is missing; the grill is to prevent hedgehogs and the like falling in and blocking the drains.

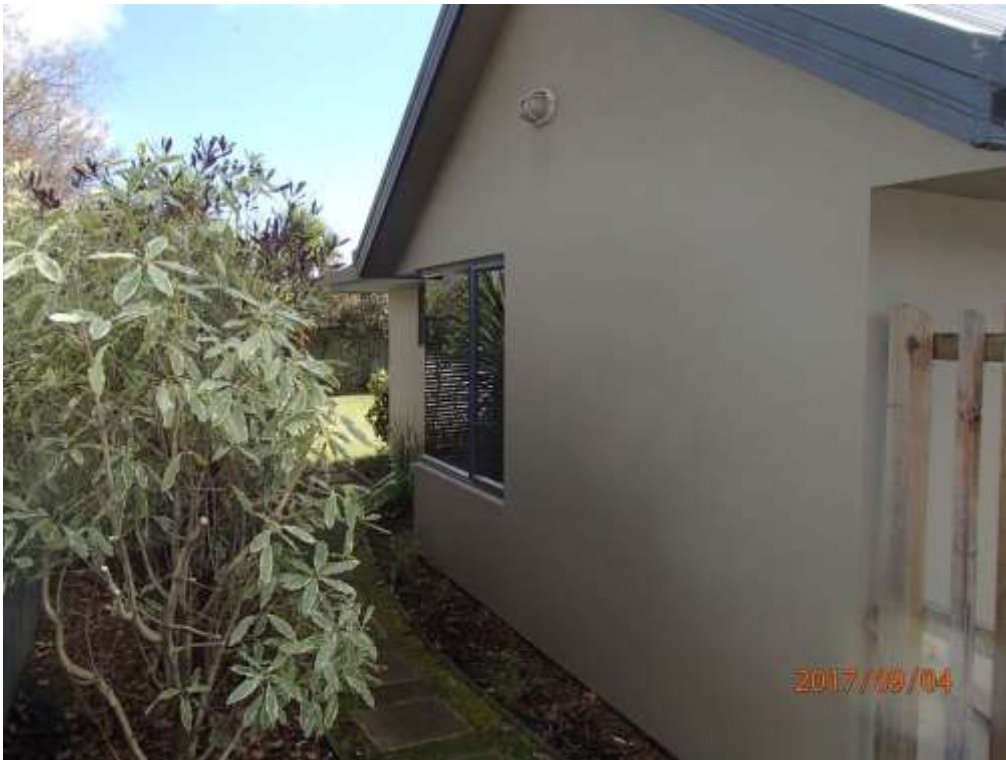
Southwest

This area backs onto the school grounds. Bark gardens here are too high and need to be lowered, especially around the western corner where it is above the bottom of the cladding. Plaster along this wall is not affected by UV or heat so is in better condition just dirty.

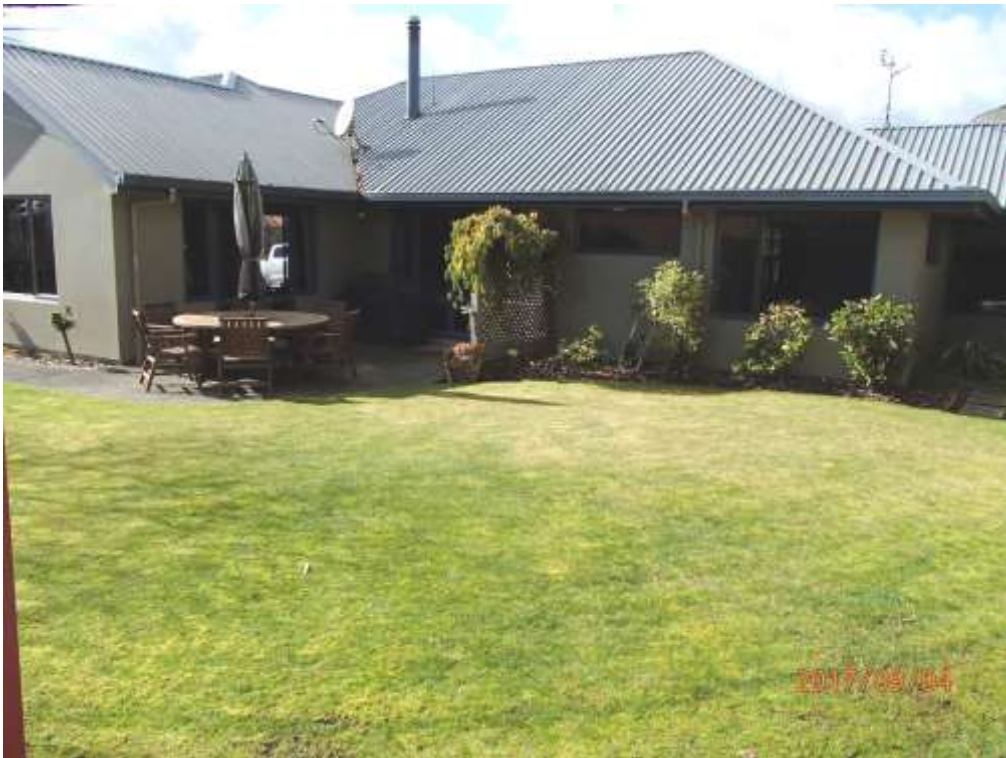
Northwest

This is the outdoor living court area with areas of exposed aggregate concrete paving which has cracked and slumped along the outer edges. I have not seen the drainage plan for this house but I believe the sewer and stormwater run along this side and the paving may have been poured before the backfill over the drains had a chance to compact. It should eventually be replaced.

These patio areas are not attached to the house so slumping along the outer edges should have no effect on the house foundations.

Cracking in the plaster to the corners of windows and the lifting of the plastic sill flashing under the plaster as well as the cracks in the face of the plaster all need to be fixed. The sills should be replaced, all cracks repaired and the wall repainted. Clear sealant is not a suitable repair.

There were no apparent elevated readings internally that might suggest a failure of the cladding at this stage.

There are bruised corners to the plaster which expose the plastic corner flashings. This damage needs to be repaired.

The curved wall is polystyrene over a timber frame and posts. It's a bit wobbly and I believe its life is limited as water is getting in at the top. Even where the gate hinges go into the wall there is movement suggesting there may be rot in the timbers or the hinges do not screw in very far.

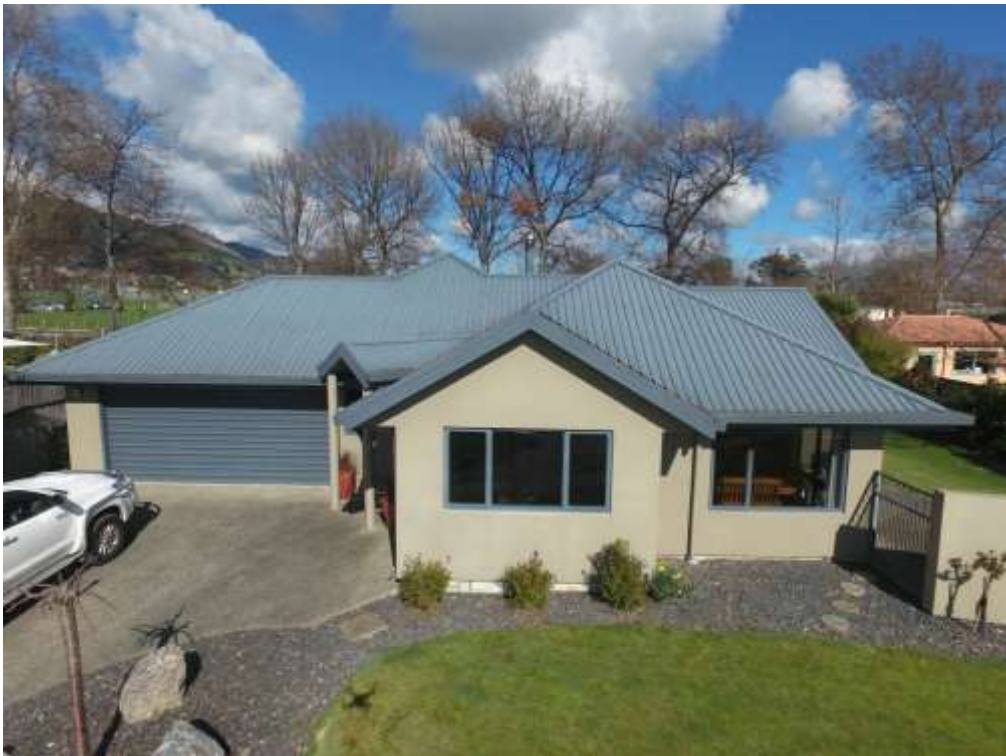
Northeast

This is the front of the house with a sloping lawn, exposed aggregate drive to the garage and path to the front door.

Plaster sills are in poor condition and need urgent repair.

Apart from the damage to the plaster the wall appears to be in very tidy condition and when repaired and painted should be fine.

There is some minor cracking in the concrete driveway but nothing of any significance.

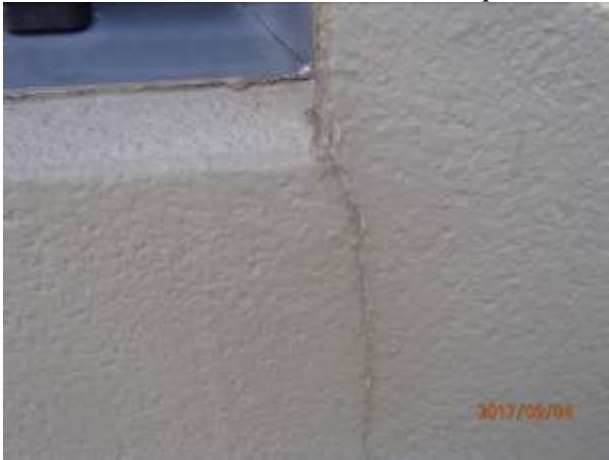
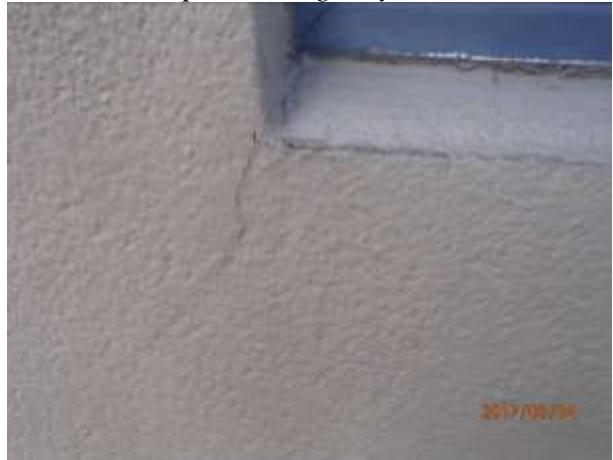
The sills to the windows need to be replaced and all cracks repaired; urgently

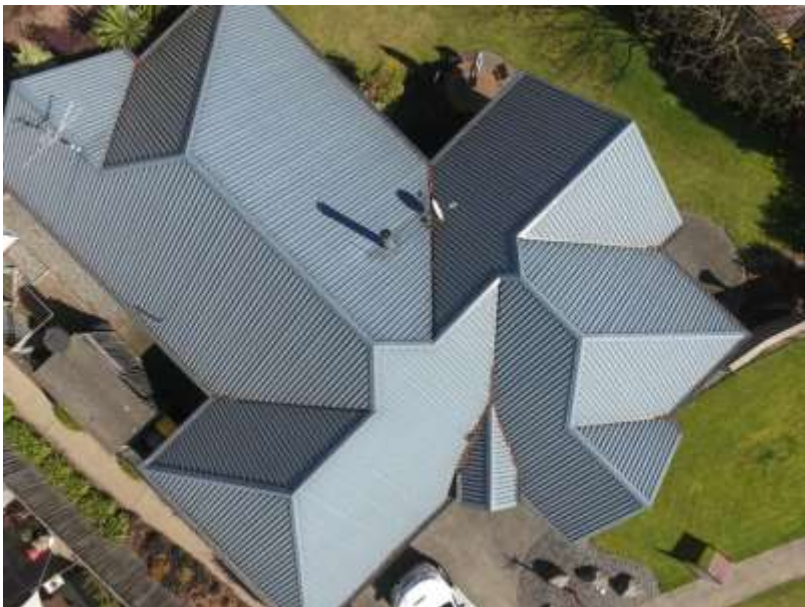
Roof

The roof was inspected with the use of a drone and from vantage points.

The roof is a little complicated and clad in trapezoid profile colour coated steel with matching fascia and gutter. It is quite steep providing great run off and plenty of attic space.

It has hips, valleys, ridges and gables with leaf guard on the outer gutters but not on the valley gutters. These are blocked with leaves from the large trees in the adjacent properties and will need to be kept clear and blocked valley gutters restrict the water flow which can cause the gutters to overflow, this is typically inside the house.

There were no current signs of failure due to this but the leaves are building up.

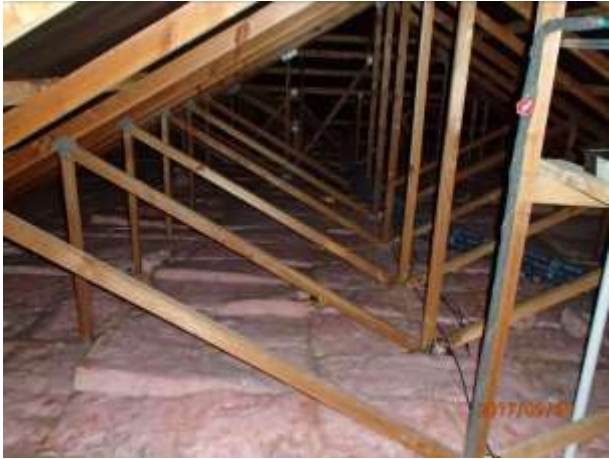
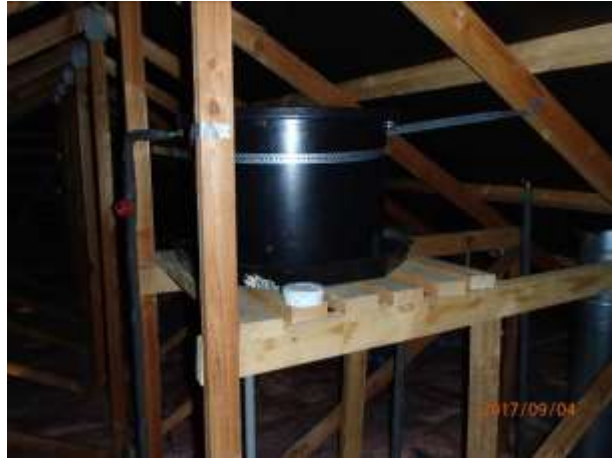
It looks like a towel has been jammed around the chimney flue so the reason for this should be sorted out but of greatest concern is a significant roof truss has been cut out to allow the passage of the flue from the fire. This will need to be inspected by an engineer and a repair designed and installed. When the replacement fire is installed the flue may be in a different place and may allow an easier repair to the flue.

The batts and header tank are all tidily installed

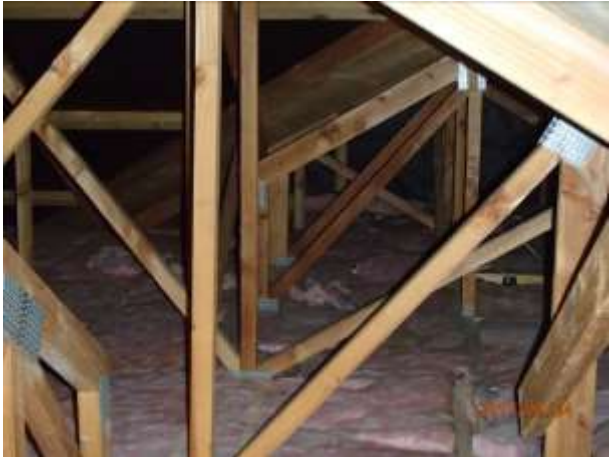
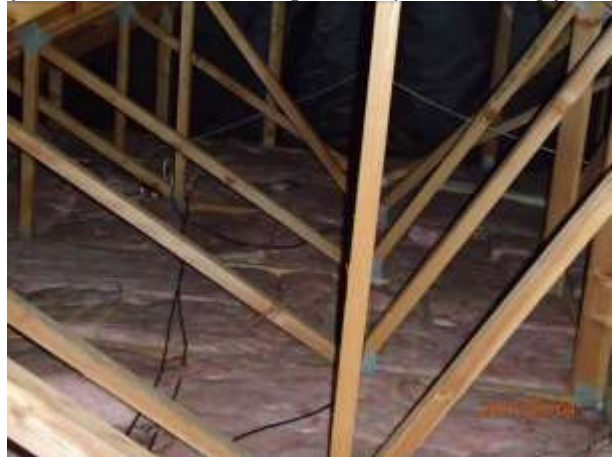
Roof framing and the insulation all looks tidy
