Residential property inspection report.

Inspector/s: Keith and Bronwyn Langham, ASAP Building Inspections Ltd.

To carry out a pre purchase inspection of the property at Home at last and then, provide a written report on its current condition. We have not inspected or reported on minor damage, wear and tear etc and have not reviewed the council files.

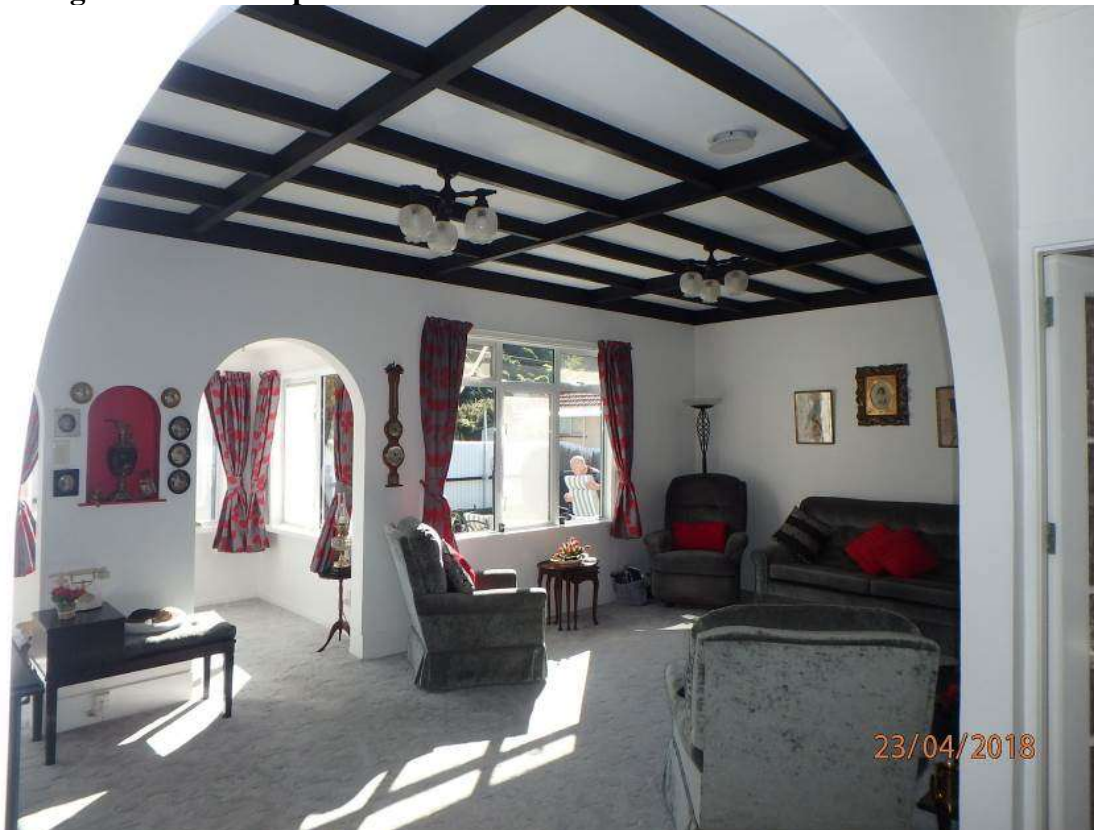
Lounge: northwest aspect.

This room has exposed ceiling joist at around 2.6 m high.

The window is in the northwest wall to the north of the archways into the entrance foyer.

Moisture readings in the exterior walls ranged between 12 and 16 with readings between 12.5 and 17.5 in the skirting.

No significant faults or elevated moisture readings found.

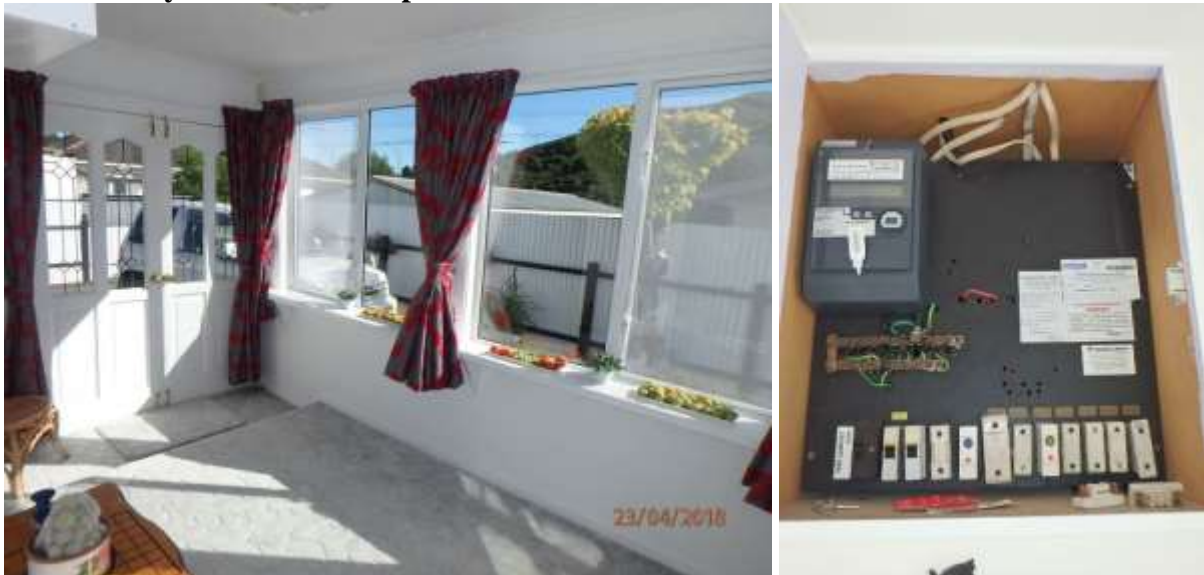
Entrance foyer: northwest aspect.

I believe this area was probably a porch that has been enclosed; the wall with the archways into the lounge was probably an exterior wall with an entrance door.

Moisture readings in the exterior walls ranged between 7 and 9.0 so are probable lined with more modern plaster board than most of the house and the walls may have been insulated. The skirting is also quite modern.

No elevated moisture readings found.

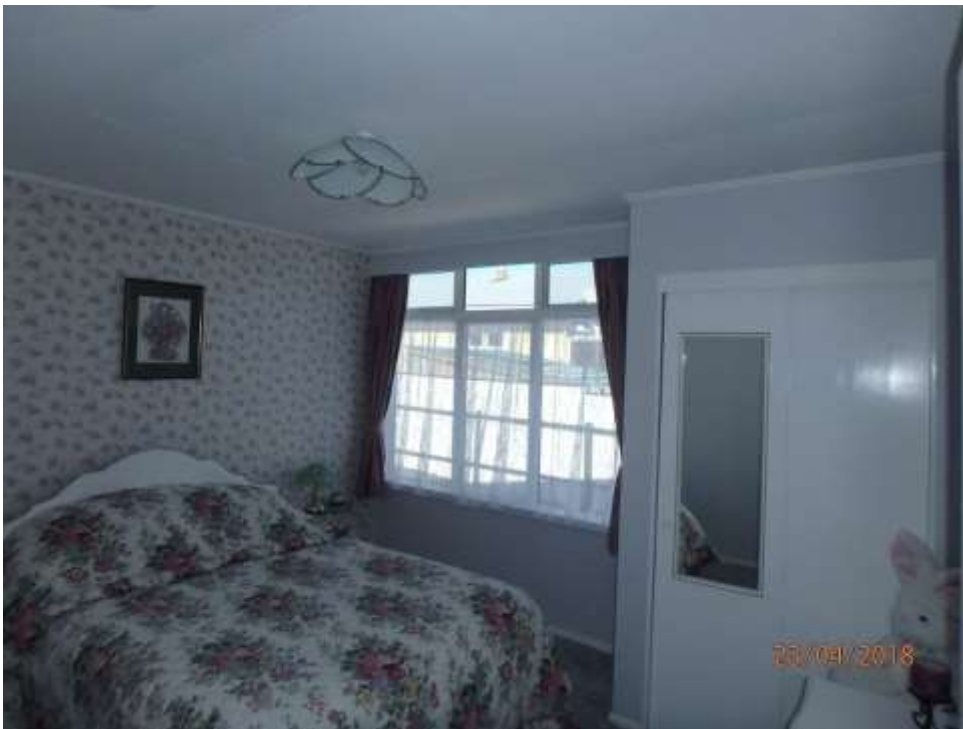
Bedroom two: south corner.

The window in this room faces to the southwest.

The ceiling is about standard height 2.4 m and is Pinex sheet with painted, perhaps PVC jointers. One sheet has a plastered patch that is smoother than the finish of the Pinex.

Moisture readings in the papered southeast exterior wall ranged between 5.8 and 8.2 with readings in the skirting between 12.8 and 17.

The papering under the paint on the southwest wall is a bit untidy and looks a little stressed at the left corner of the sill. Moisture readings in this wall lining were similar to the southeast wall but readings in the skirting were all below 12.

No significant faults or elevated moisture readings found.

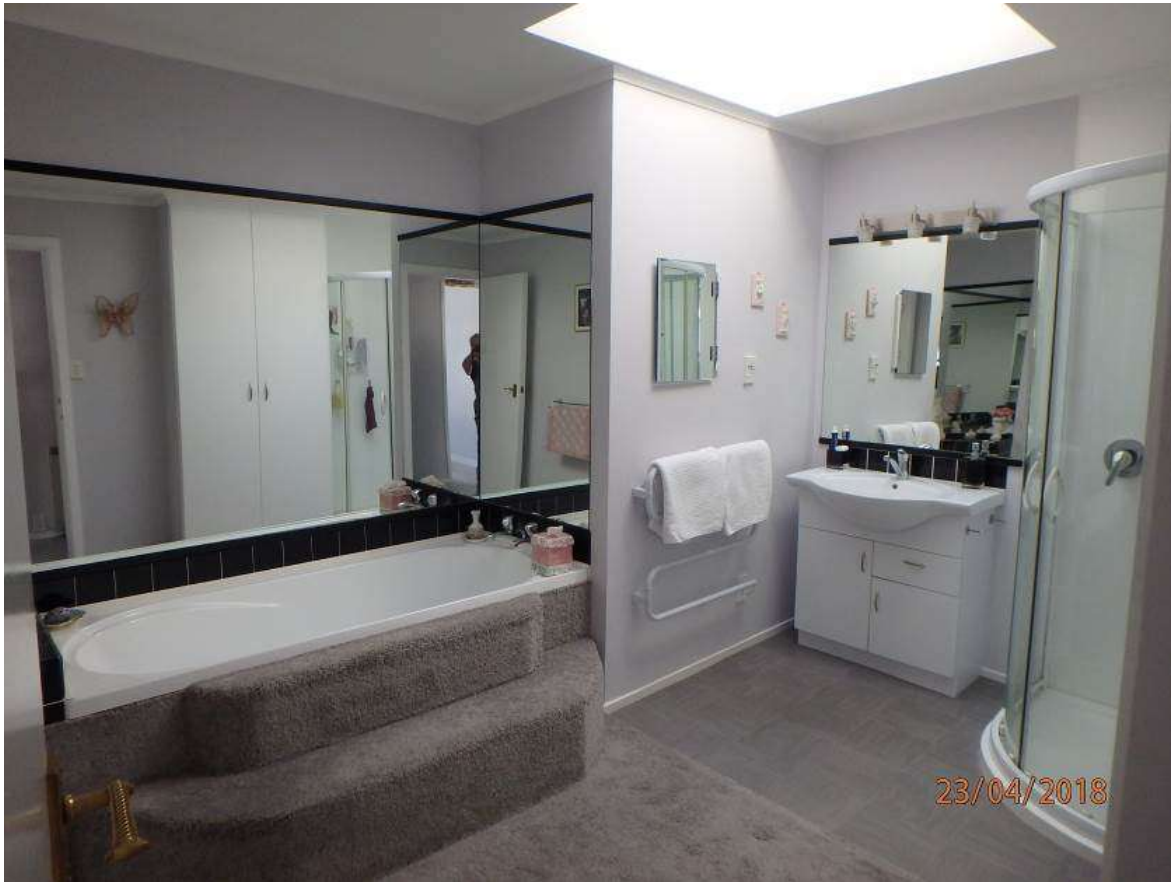
Bathroom:

This room is in the centre of the house, not an original location for this age of house. There is an opening Velux roof window in a plasterboard light shaft; the pole to activate it is hung behind the bathroom door. The linings in the shaft look tidy.

The skirting beside the bathroom door has been bevelled off to allow the door to open due to its closeness to the wall adjacent to the lounge. The floor in the doorway is uneven and I believe this is not an original doorway.

Moisture readings in the wall linings and skirtings were all quite low.

No significant faults or elevated moisture readings found.

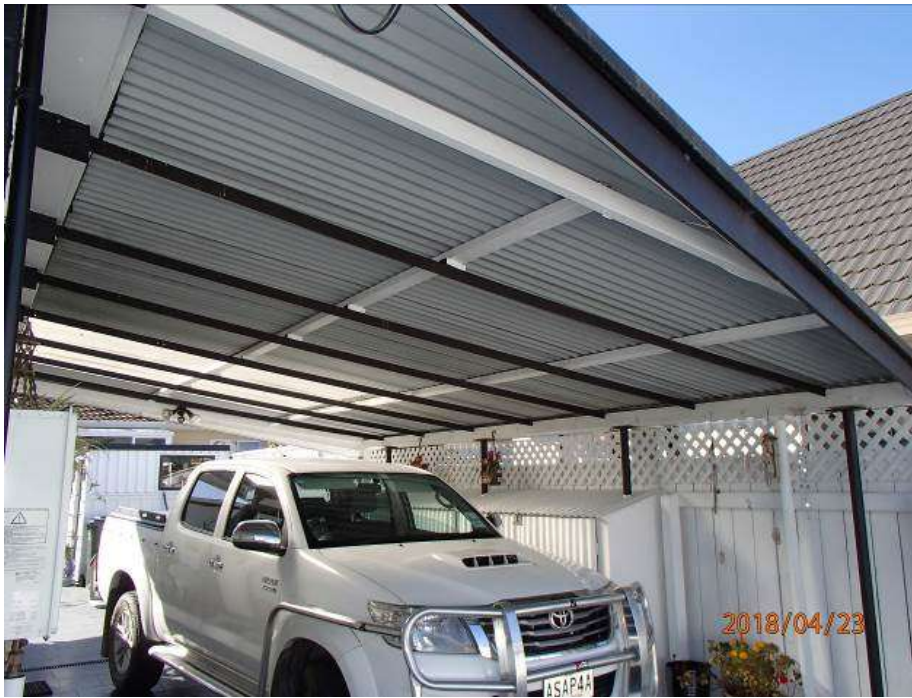
The structure appears to held up with good luck rather than sound practice.

But it does provide good protection from the weather.

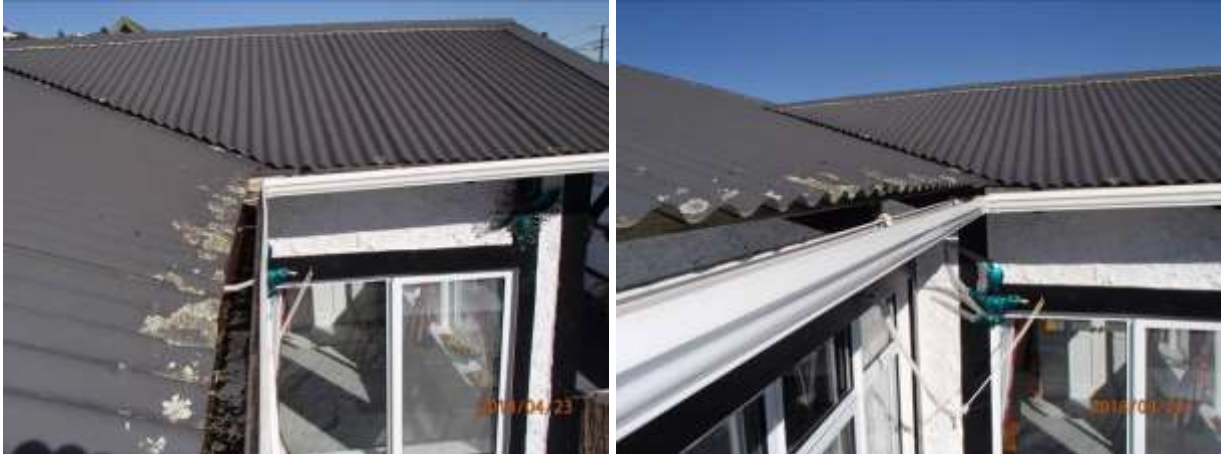
The roof is quite tidy and well flashed. Lichen is building up and should be treated

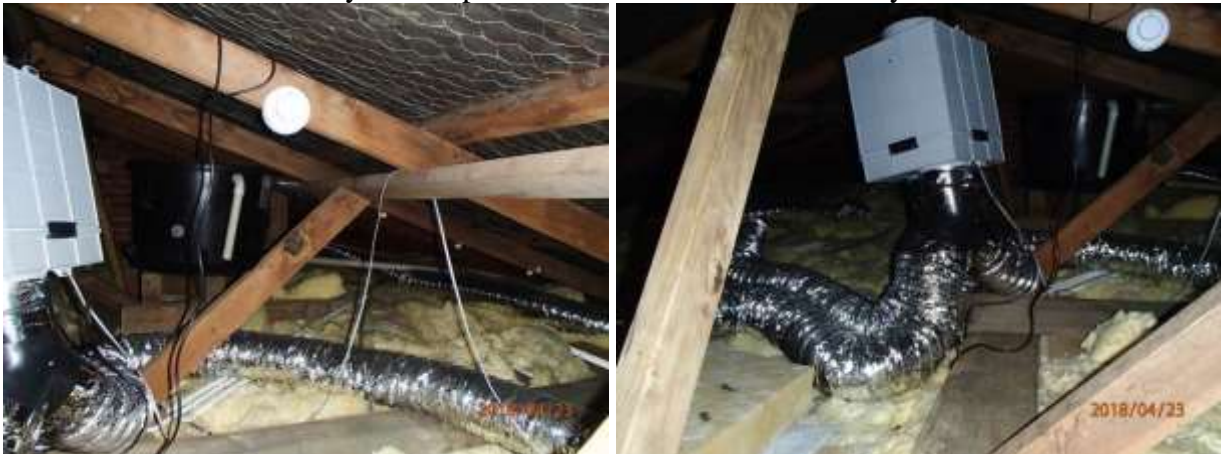
HRV system and ducting, batts are tidy enough, header tank no longer used.

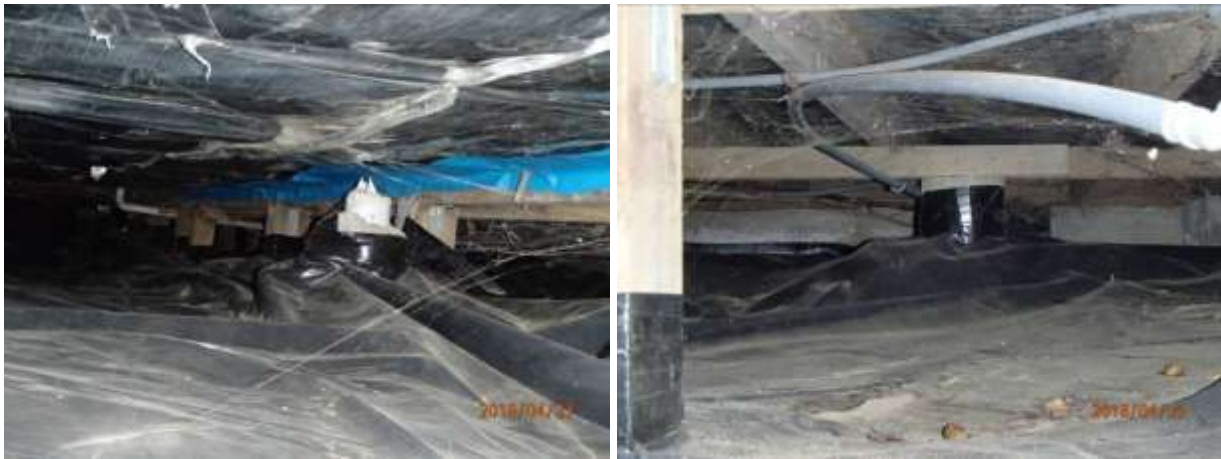
Polythene over the ground is dry, butylene plumbing, pvc wastes, all good

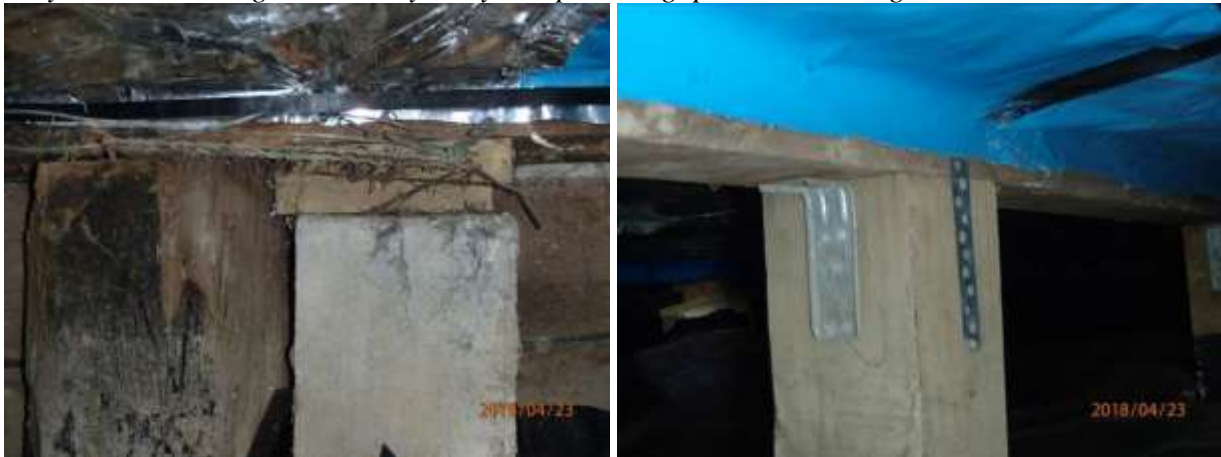
Old Totara pile, old concrete pile and now all new treated timber piles with great fixings.
